# Damage of Transportation Facility due to 2010 Chile Earthquake

April 5, 2010

Bridge Team Dispatched by  
Japan Society of Civil Engineers

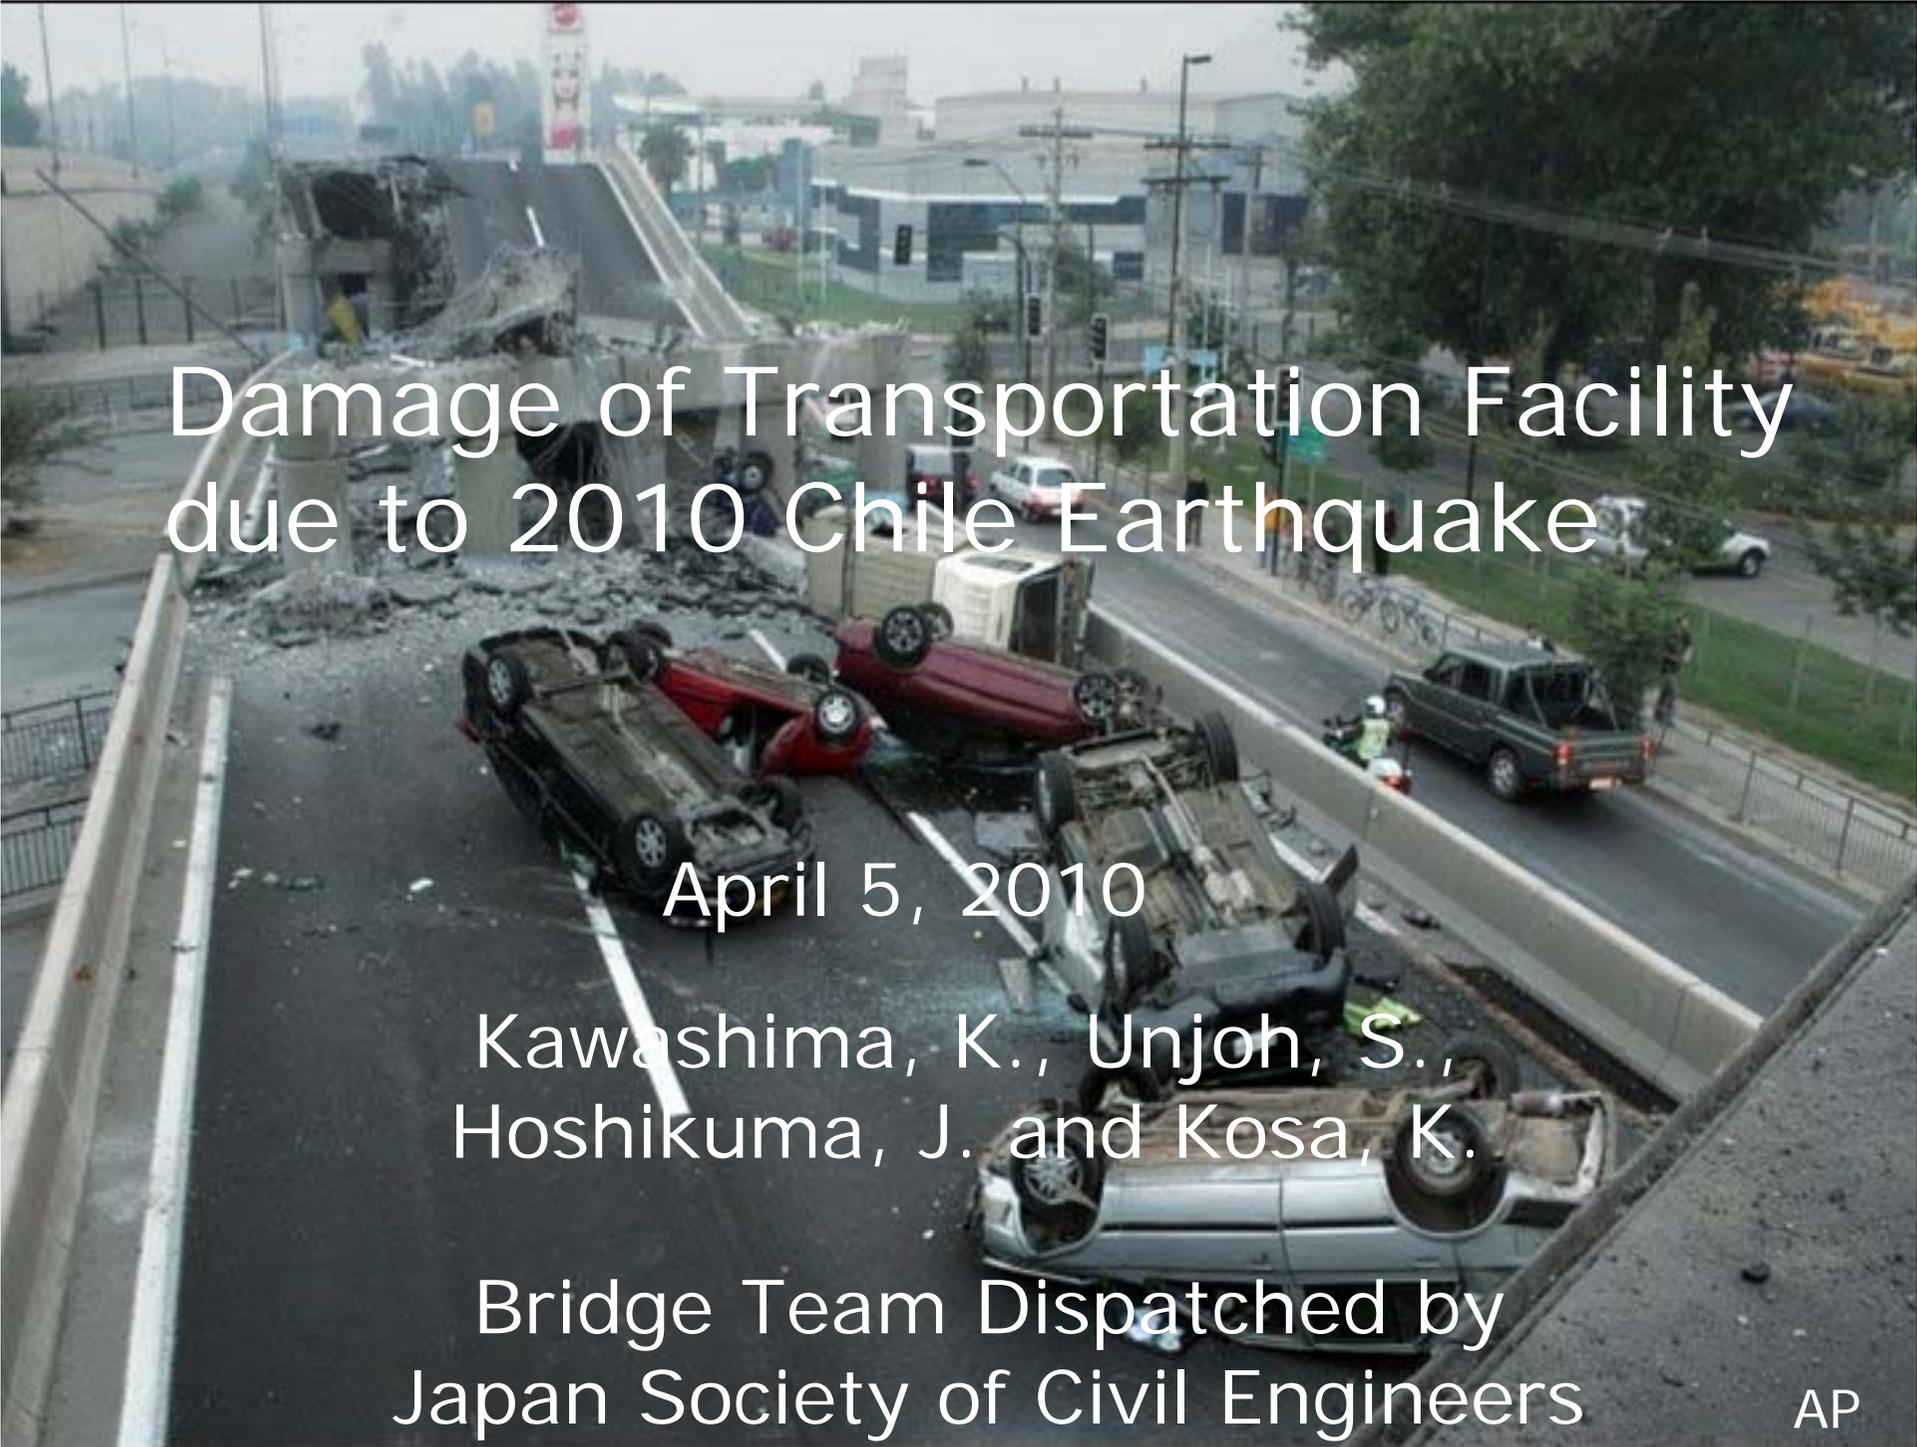
An aerial photograph showing the aftermath of a bridge collapse. The bridge deck has fallen into a deep trench, and several cars are overturned on the remaining sections of the bridge. Debris is scattered across the road surface. In the background, there are buildings and utility poles. The scene is a stark illustration of the damage caused by the 2010 Chile Earthquake.

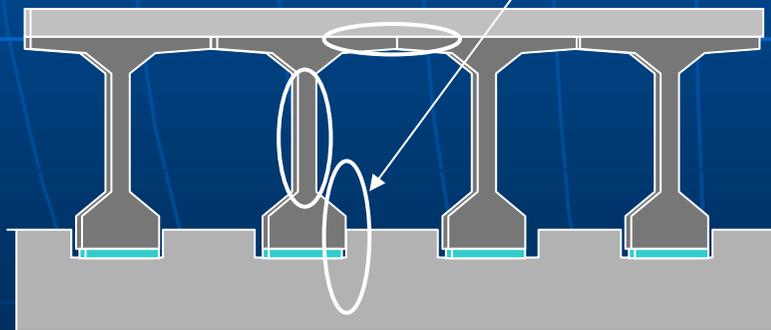
Contact of a PC girder to stopper results in failure of lower flange, shear failure of web plate, rupture of deck slabs and connection between deck slab and upper flange

Seismic force in the TR direction

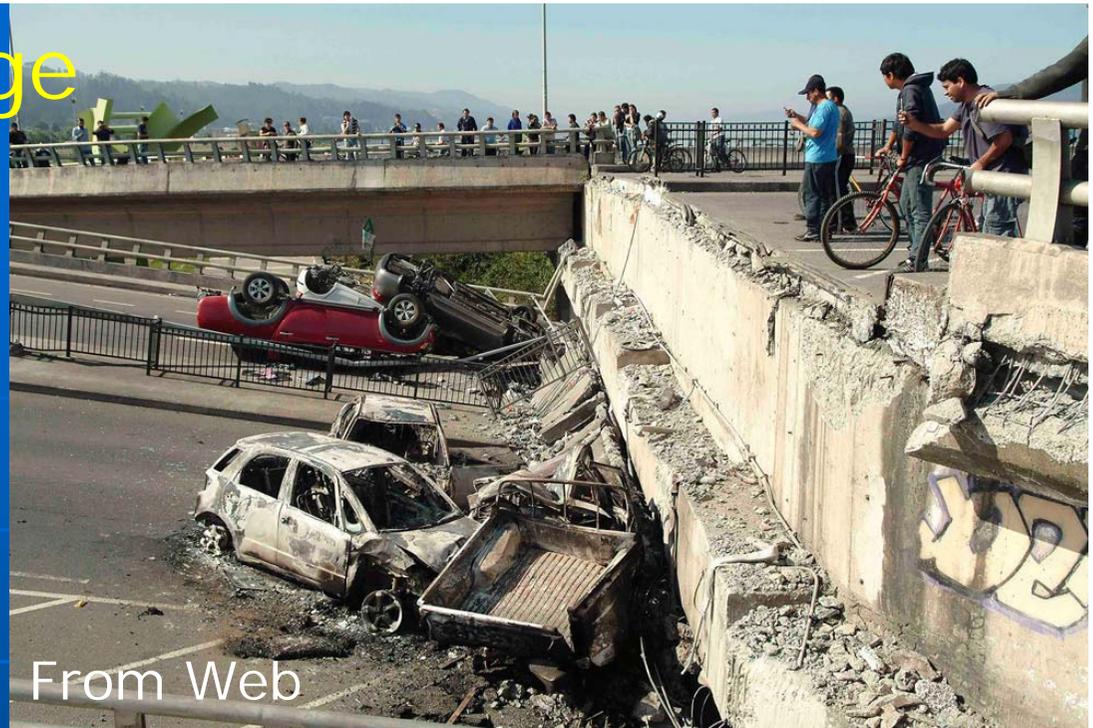
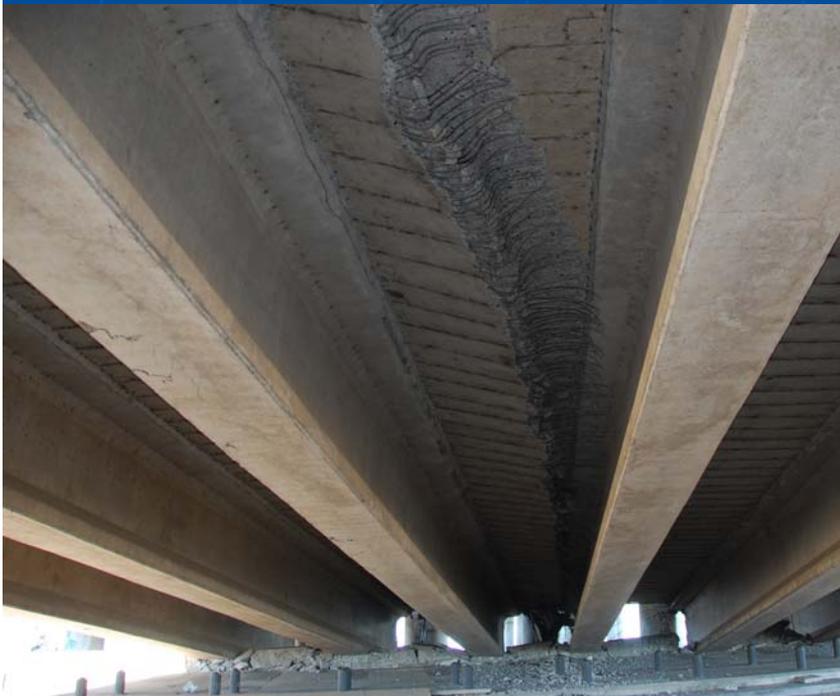
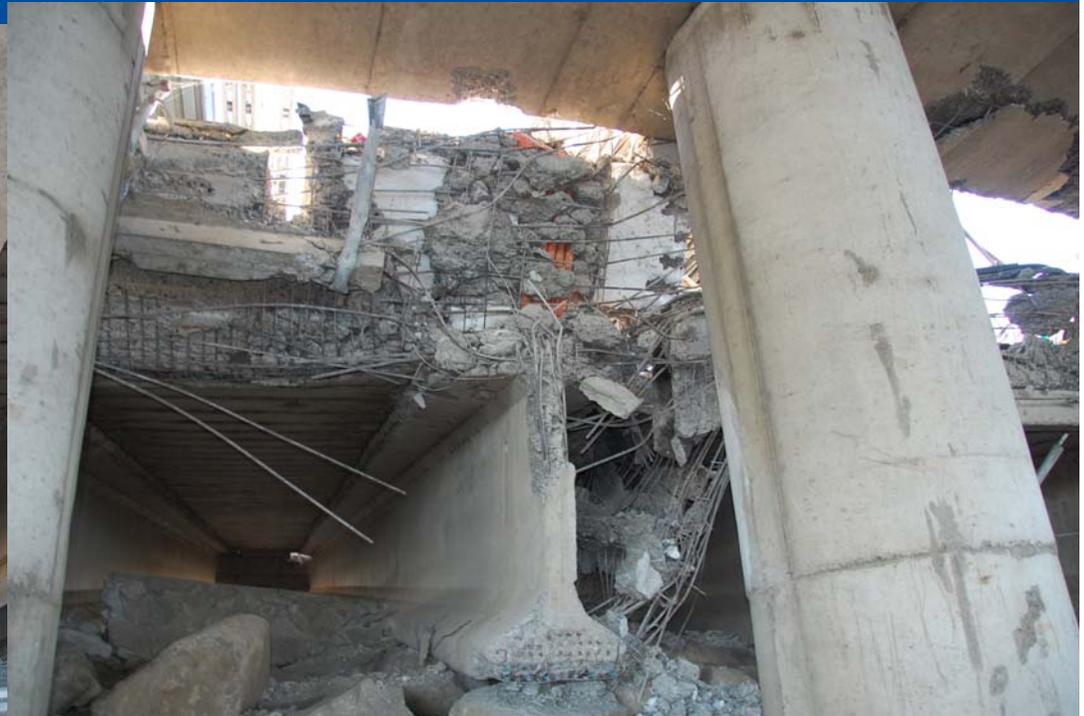
Llacolén Bridge  
Concepcion

Example of damage  
due to lack of  
diaphragms

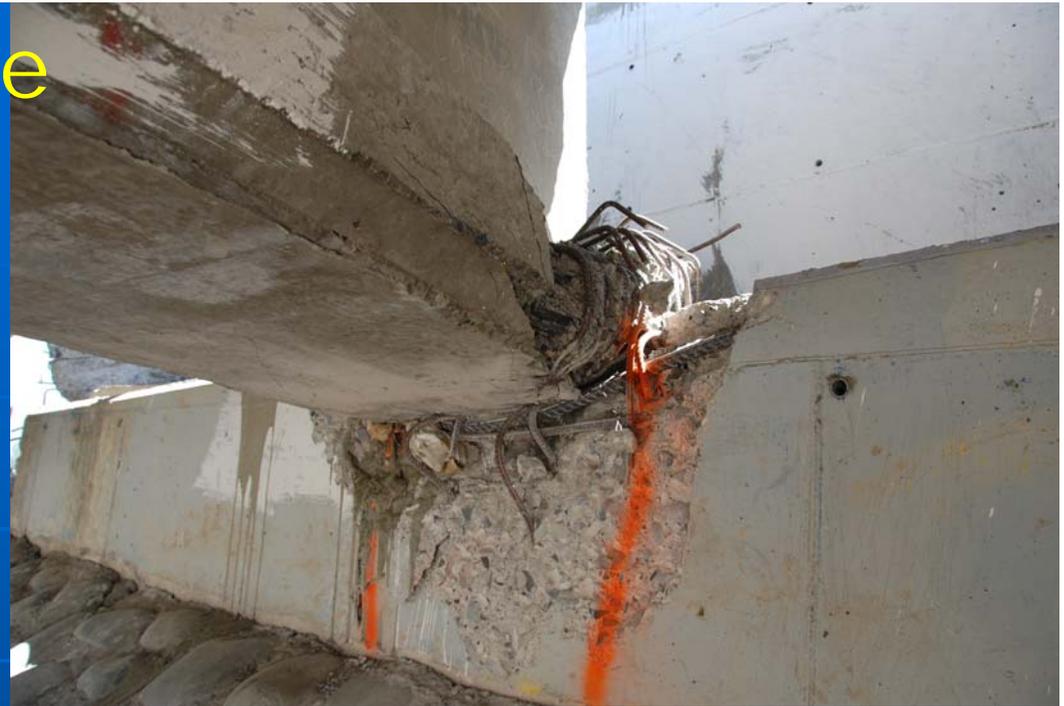
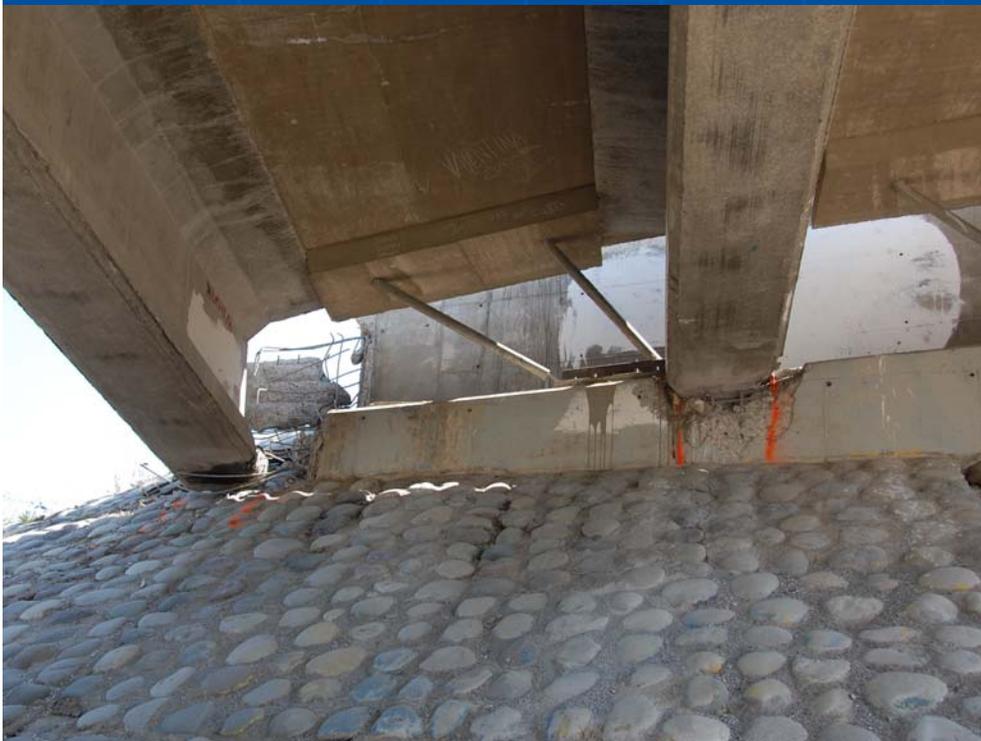
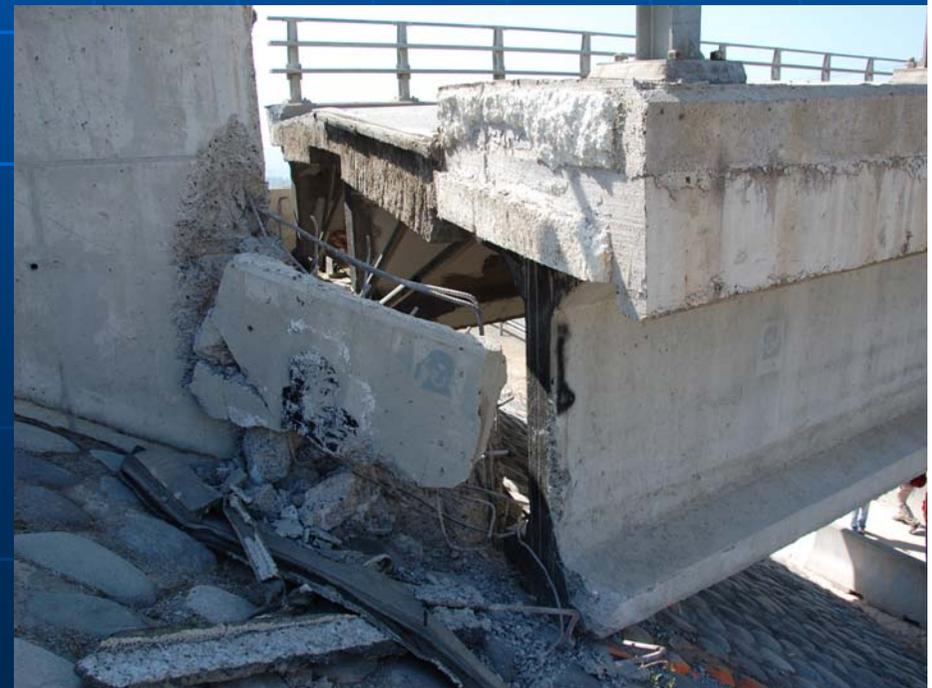
Las Mercedes Bridge  
Route 5

Example of damage  
due to lack of side  
stoppers and  
diaphragms

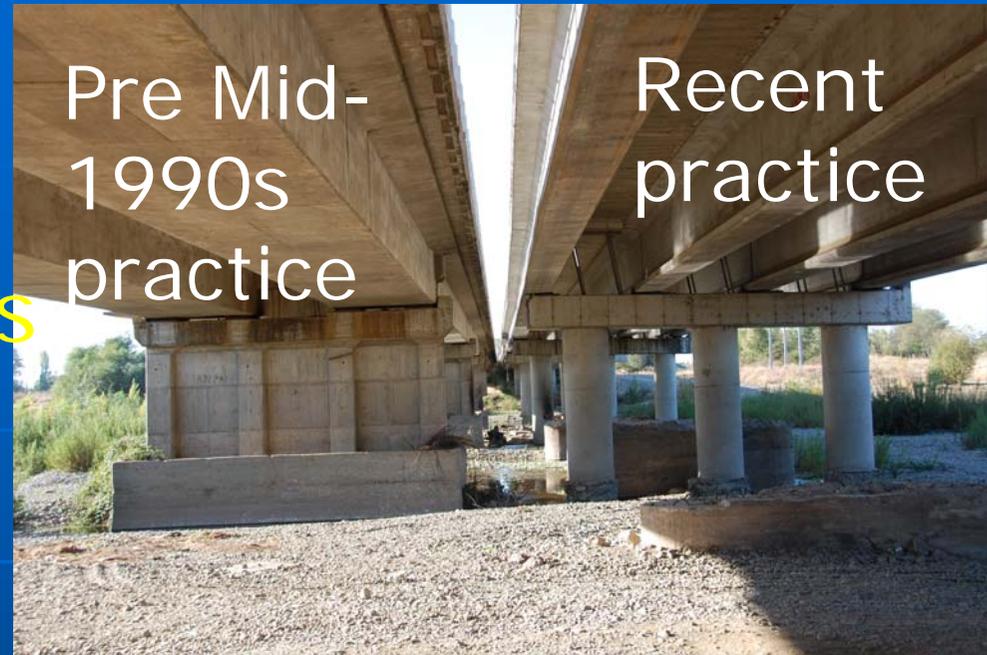
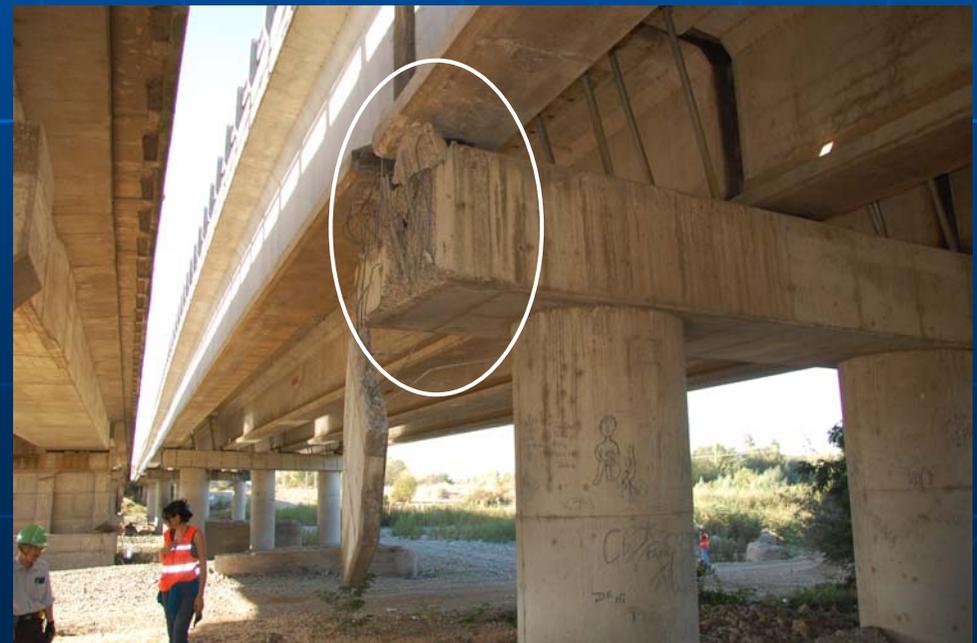
Perquillauquen Bridge  
Route 5

Very lucky!  
About to collapse

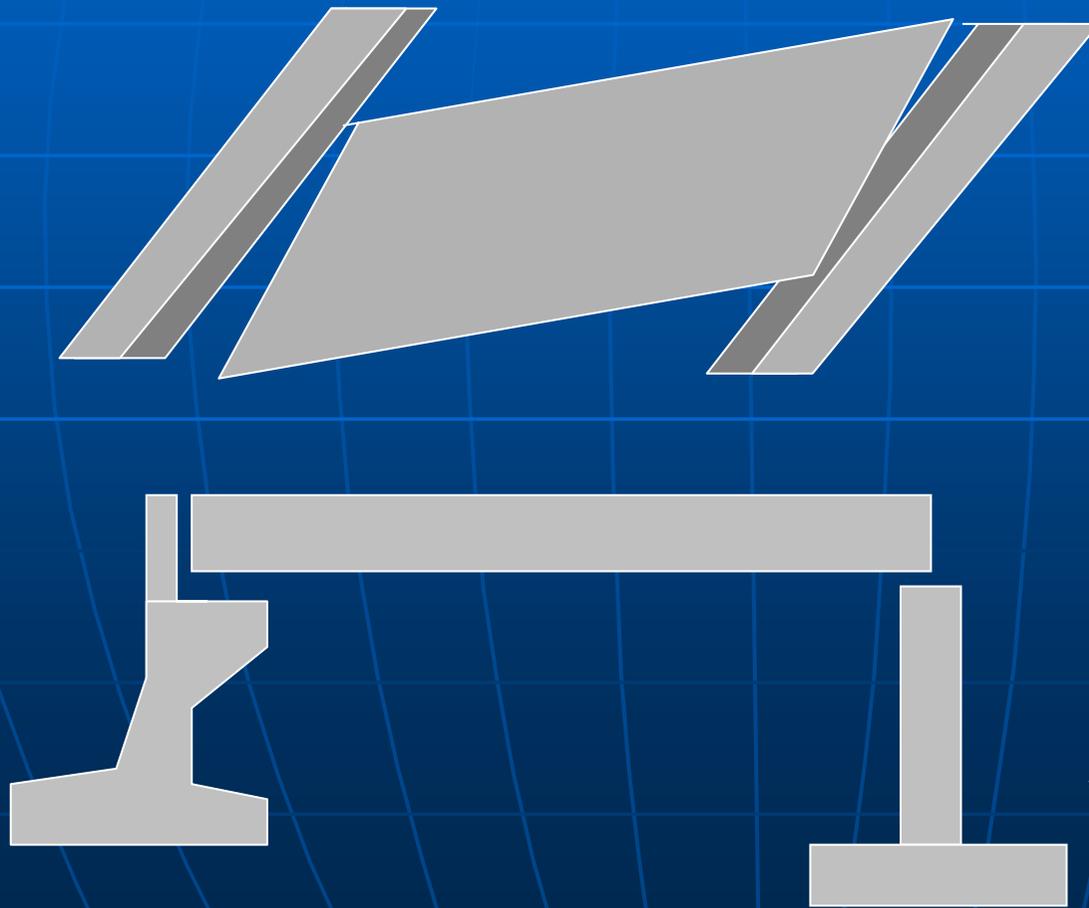
Skewed bridges tend to rotation under seismic excitation

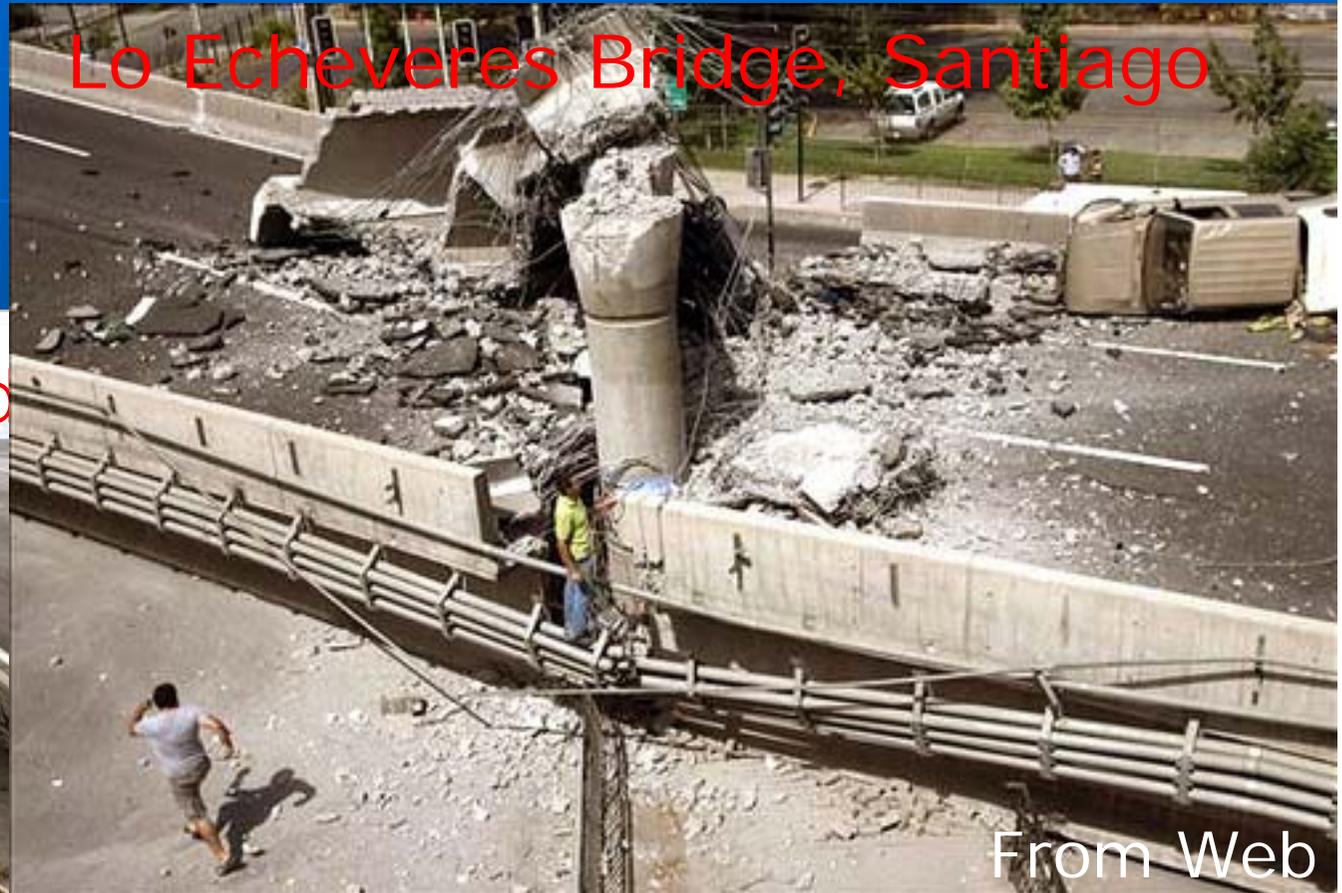
Lo Echeveres Bridge, Santiago

Skewed bridges which lacked diaphragms and effective side stoppers suffered extensive damage

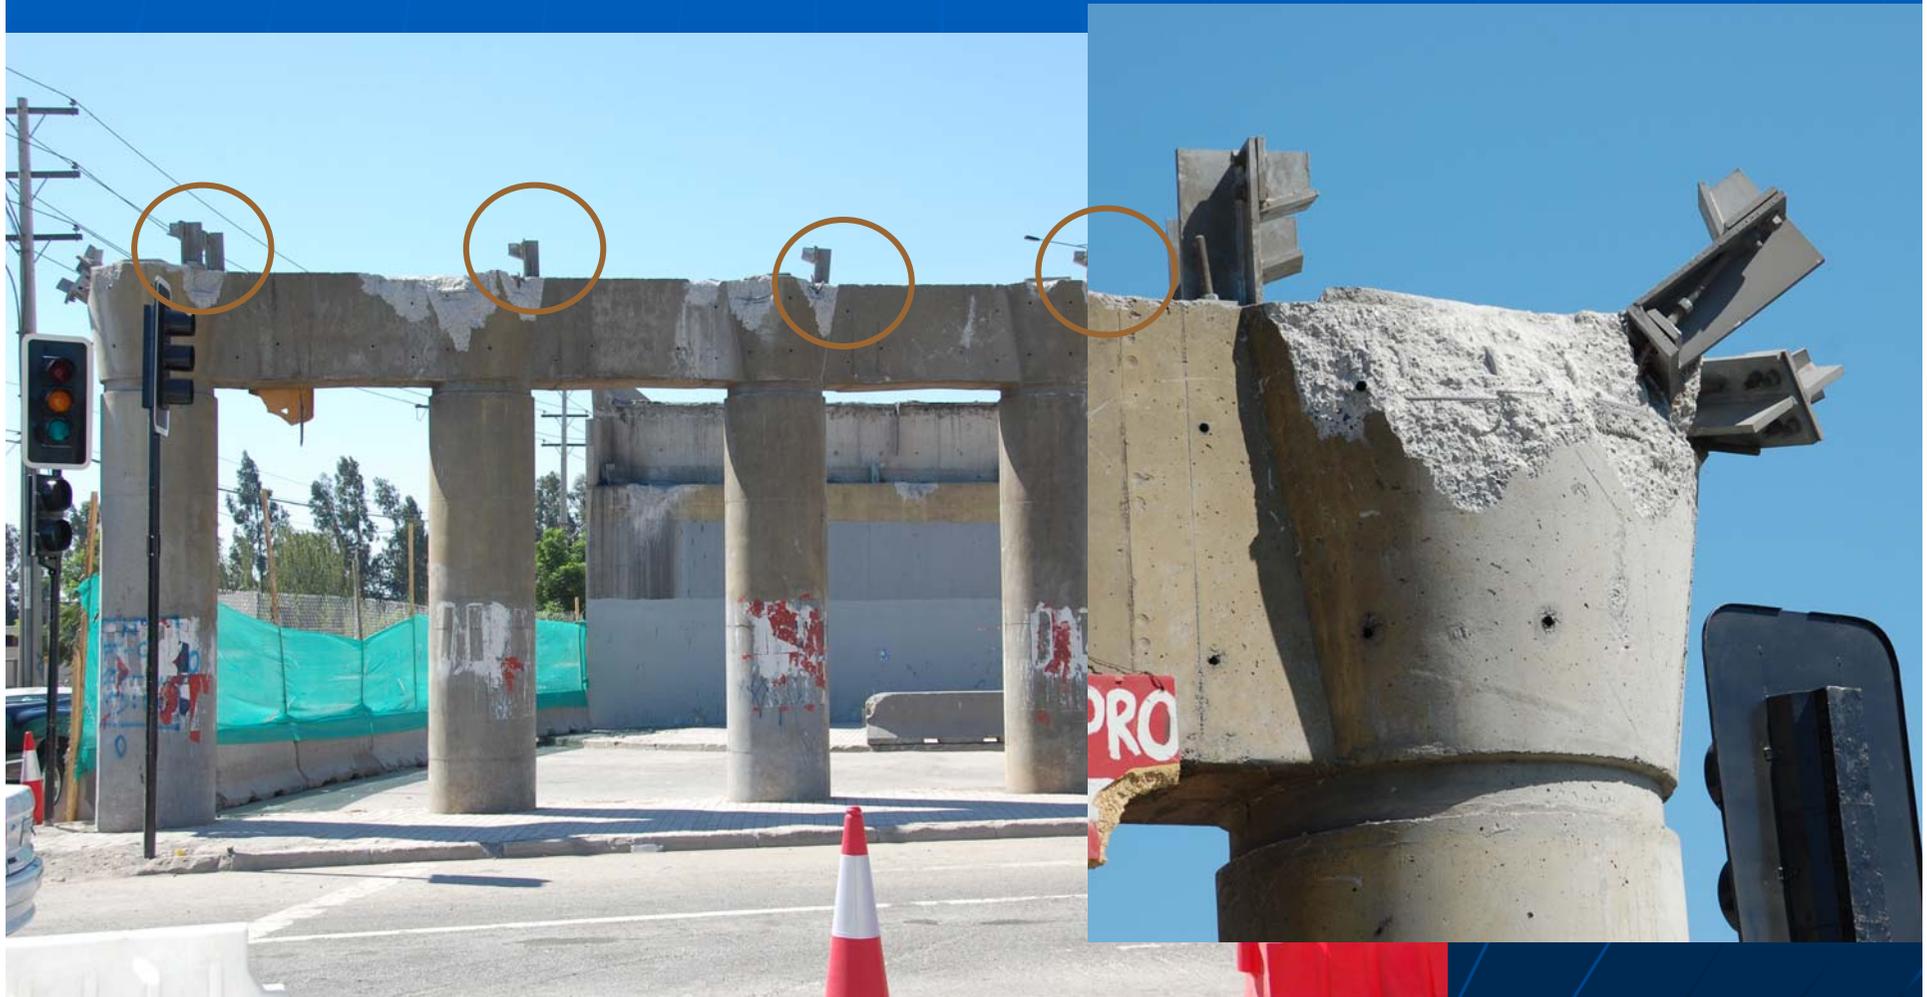
Miraflores Bridge, Santiago

# No mechanism to prevent TR and LG offset of bridges

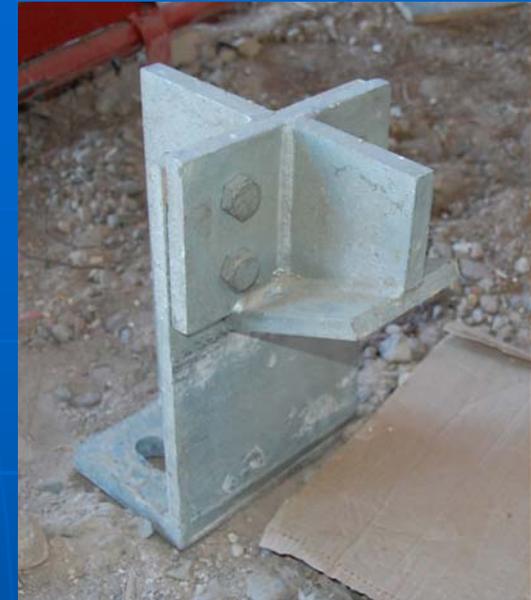
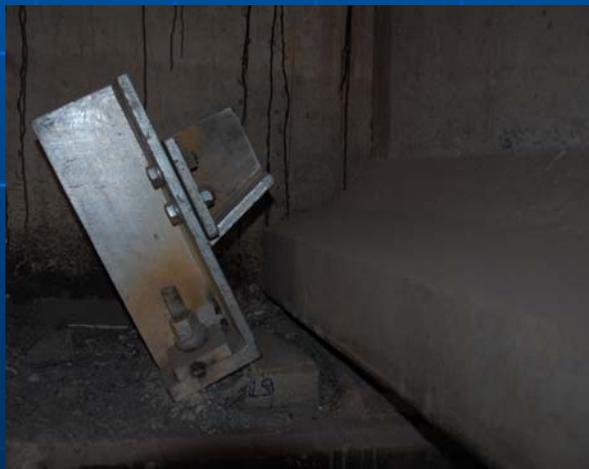
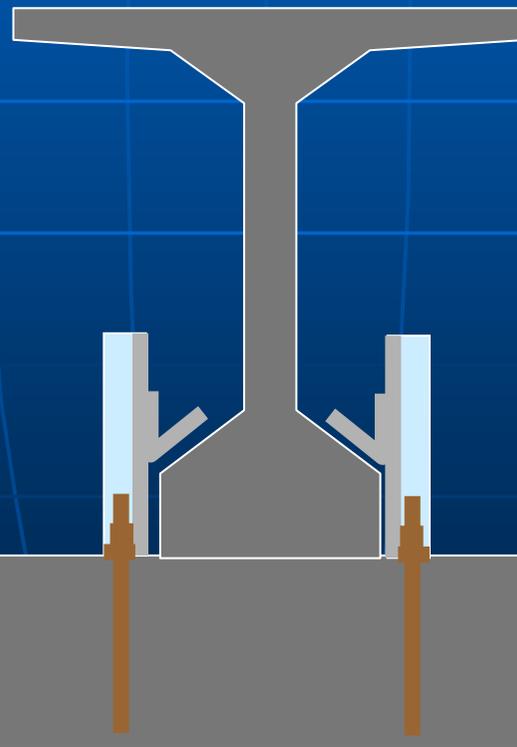
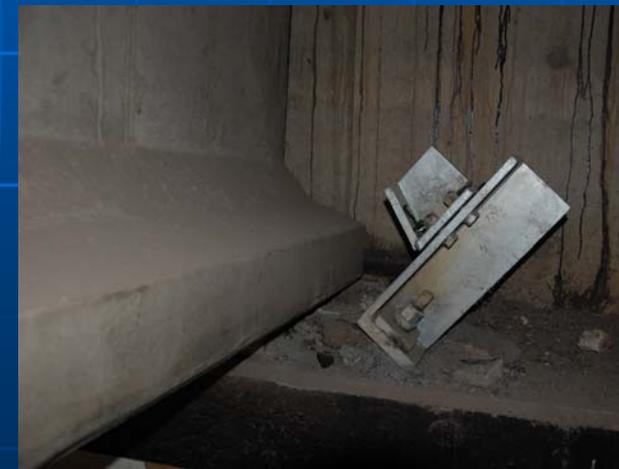
# Stoppers for uplift?

- They were set not for preventing TR offset of bridges but for uplift prevention
- They were too weak

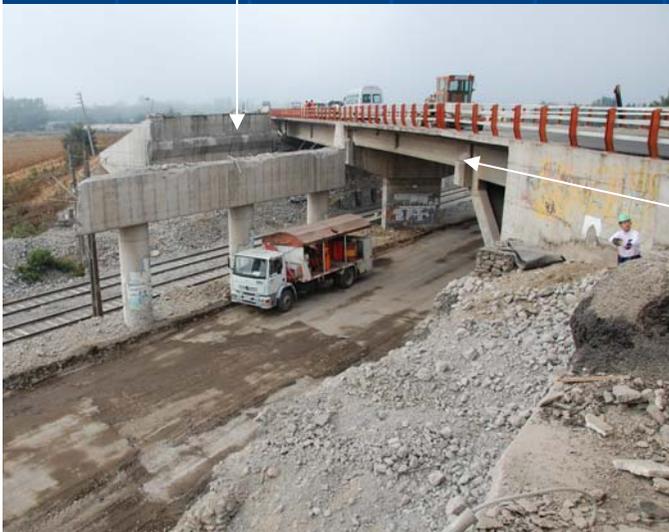
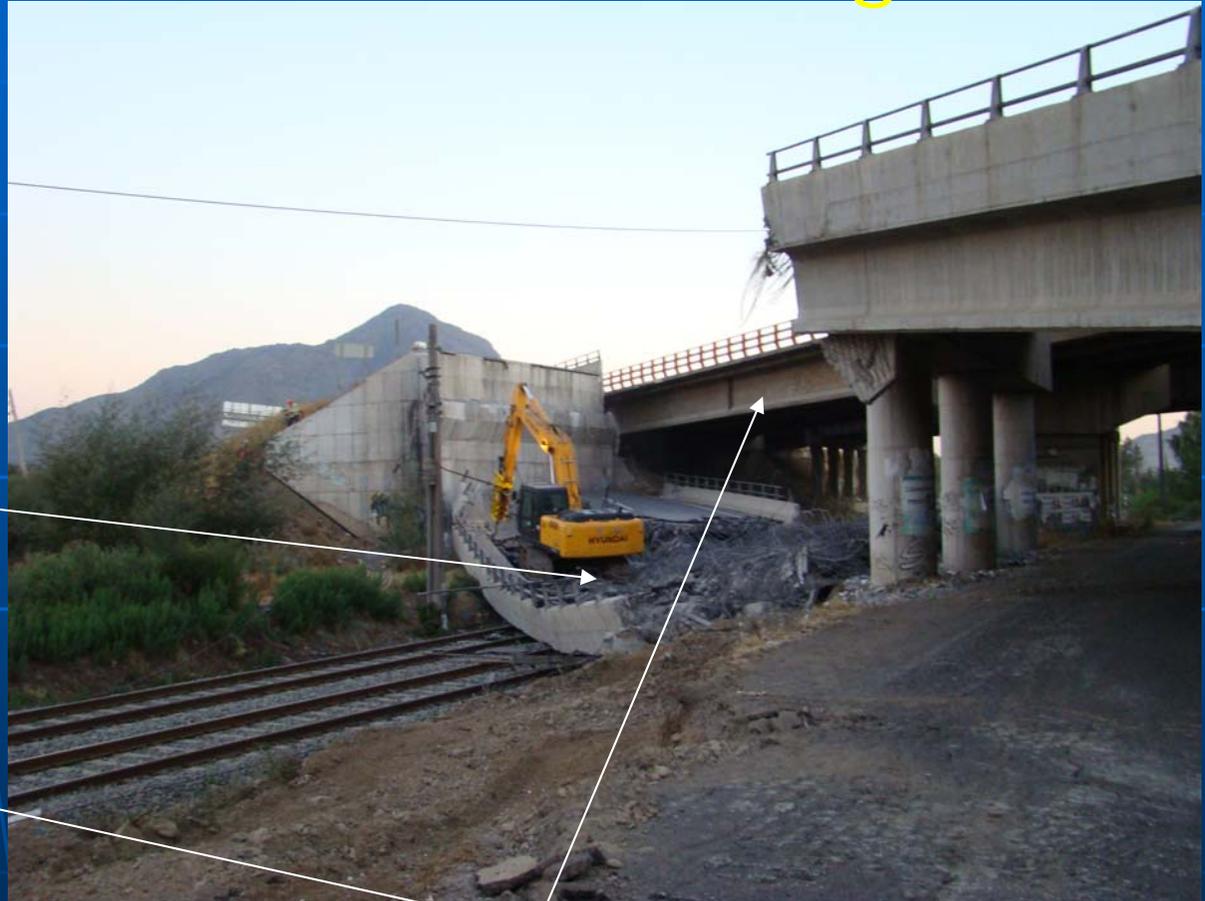
Hospital Bridge  
Route 5

Skewed PC girder bridges recently built without diaphragms and effective side stoppers suffered extensive damage

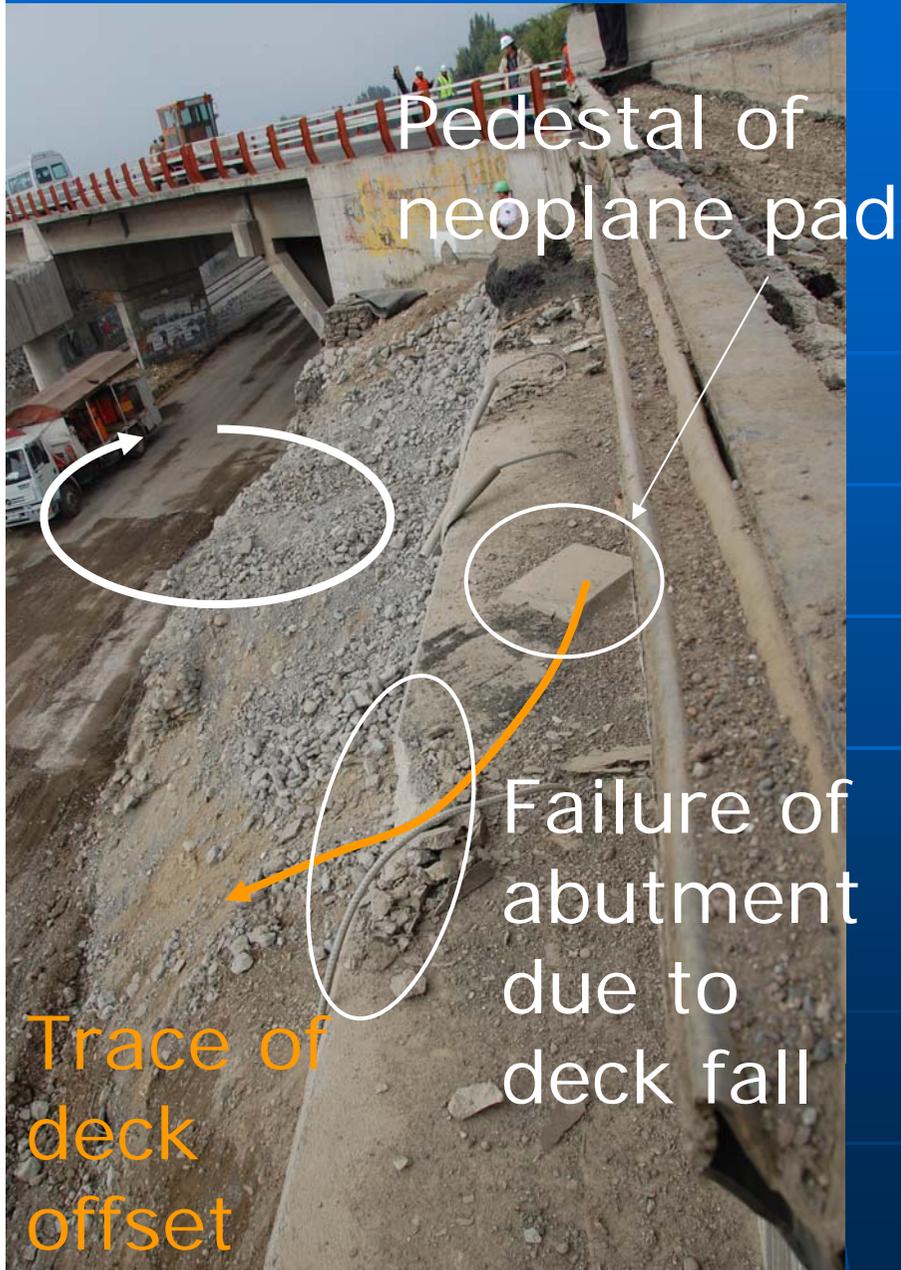
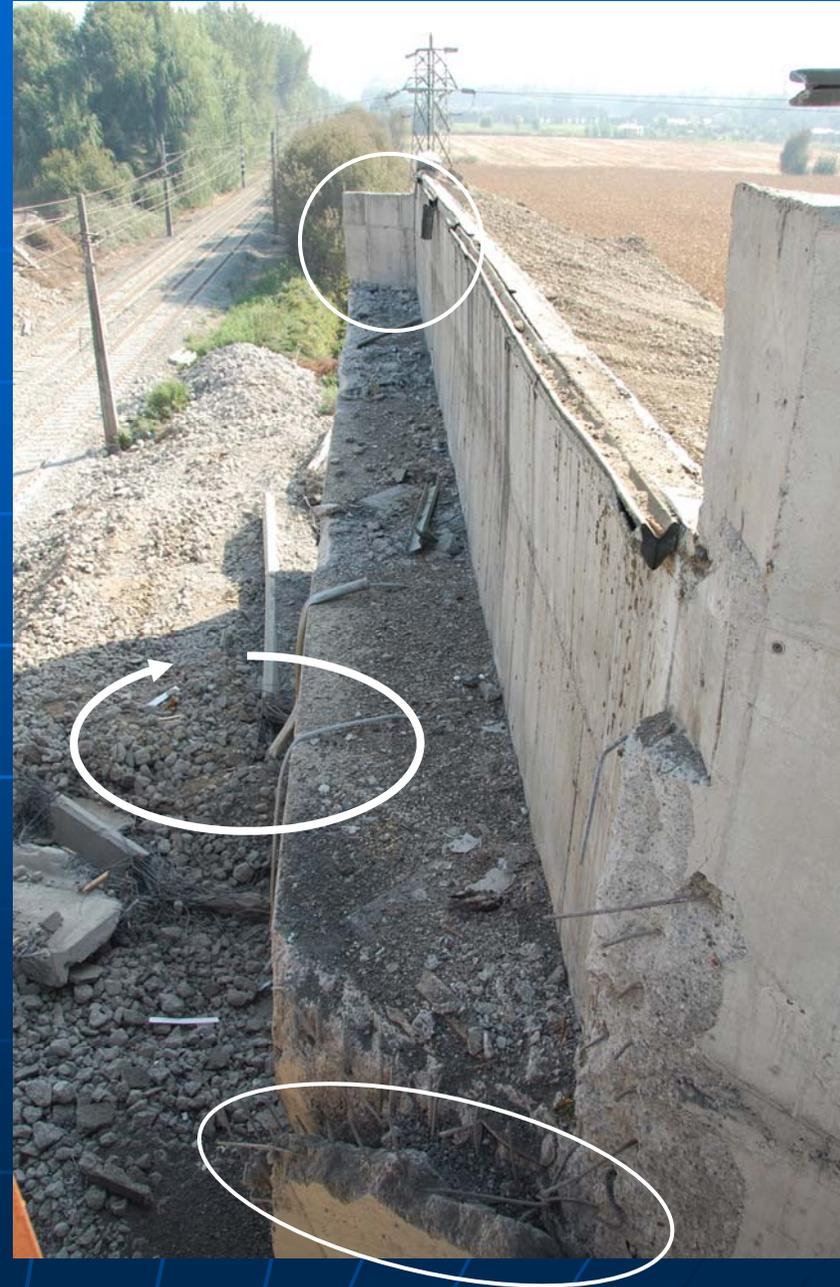
# Collapse due to rotation of a skew bridge

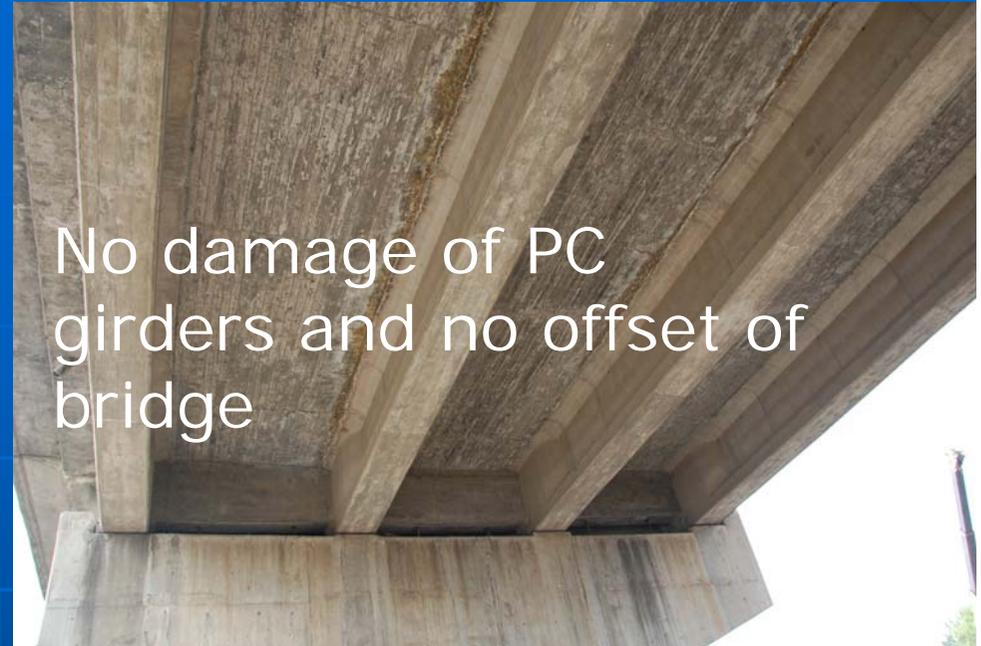
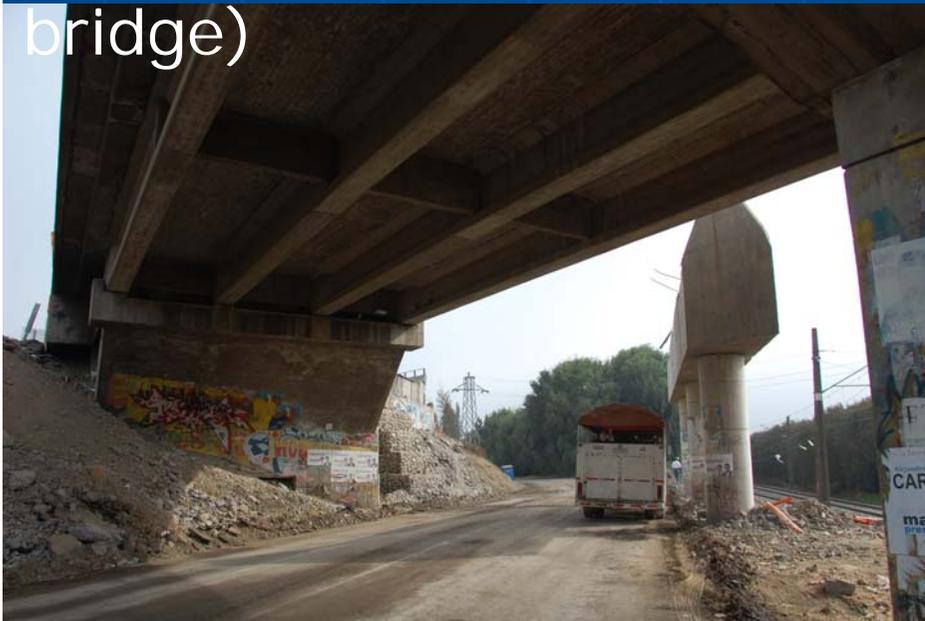
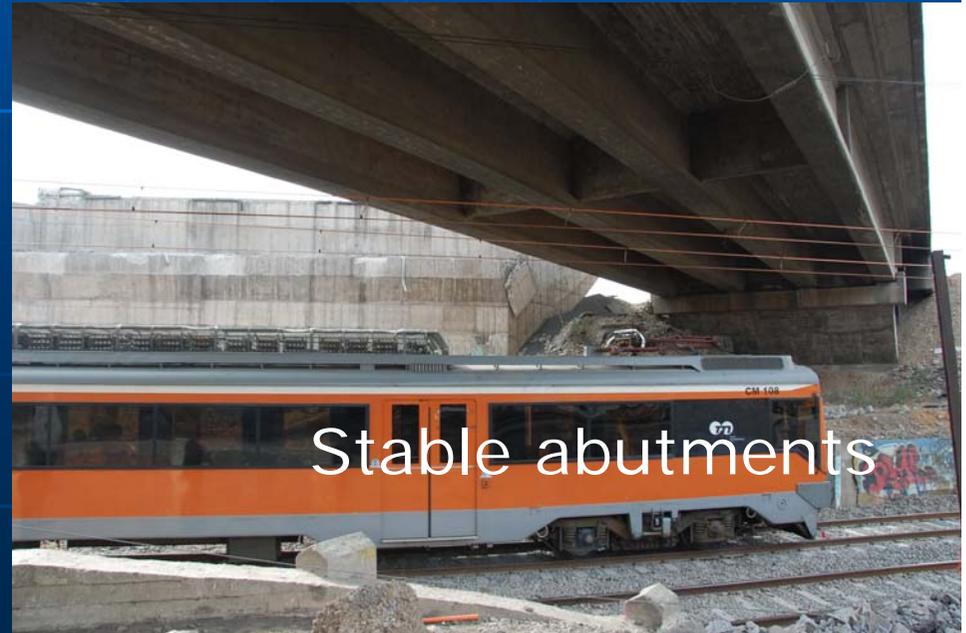
Older bridge based  
on Pre Mid-1990s  
Chile Design Practice  
performed well

Abutments and piers  
were built perpendicular  
to bridge axis (straight  
bridge)

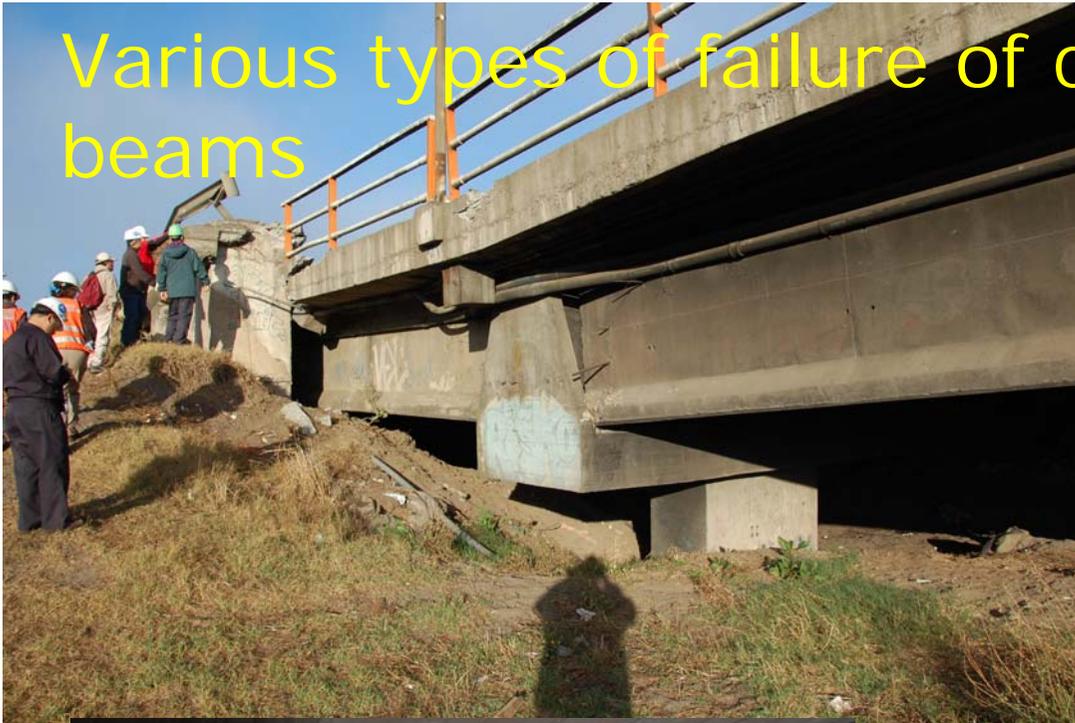
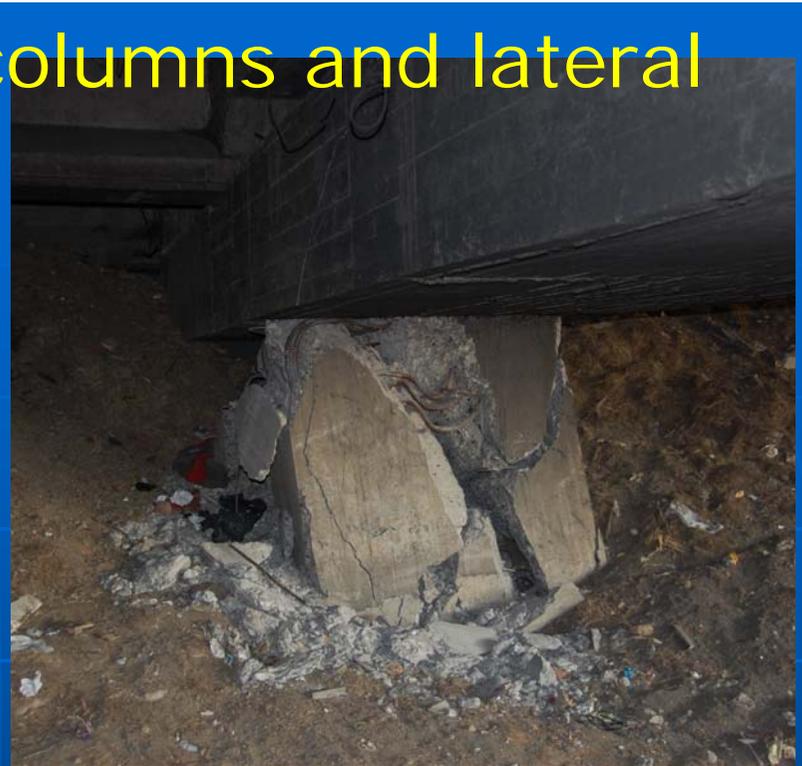
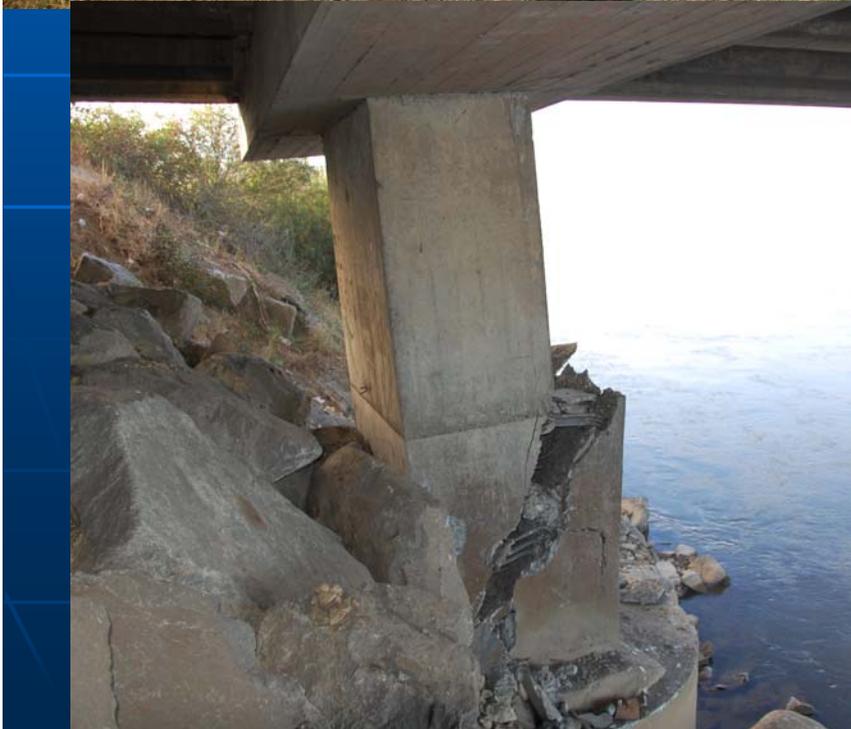
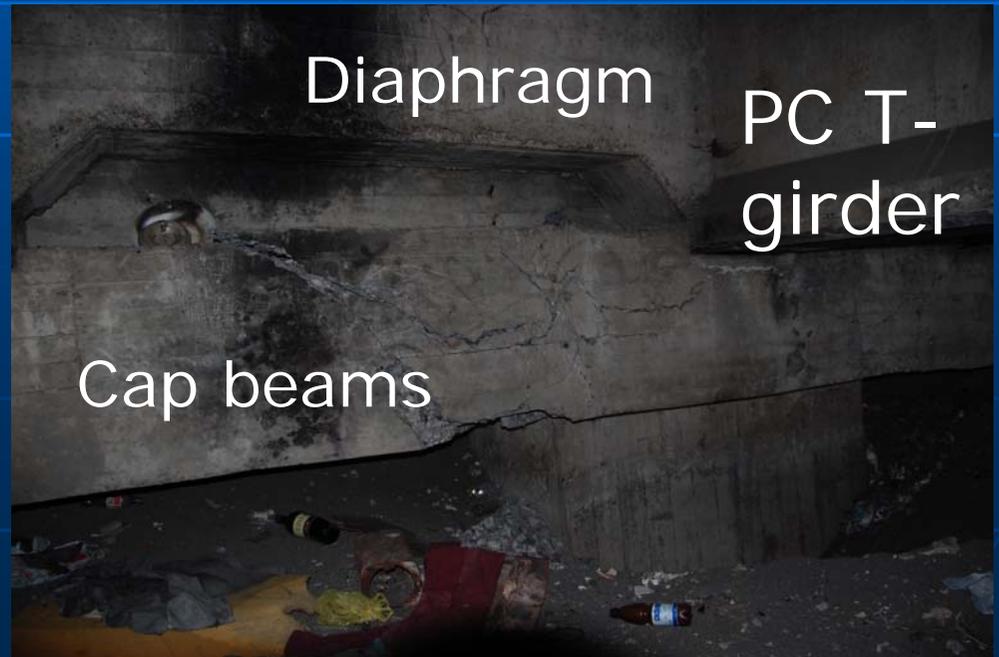
# Various types of failure of columns and lateral beams
