# Damage of Transportation Facility due to 2010 Chile Earthquake

April 5, 2010

Bridge Team Dispatched by  
Japan Society of Civil Engineers

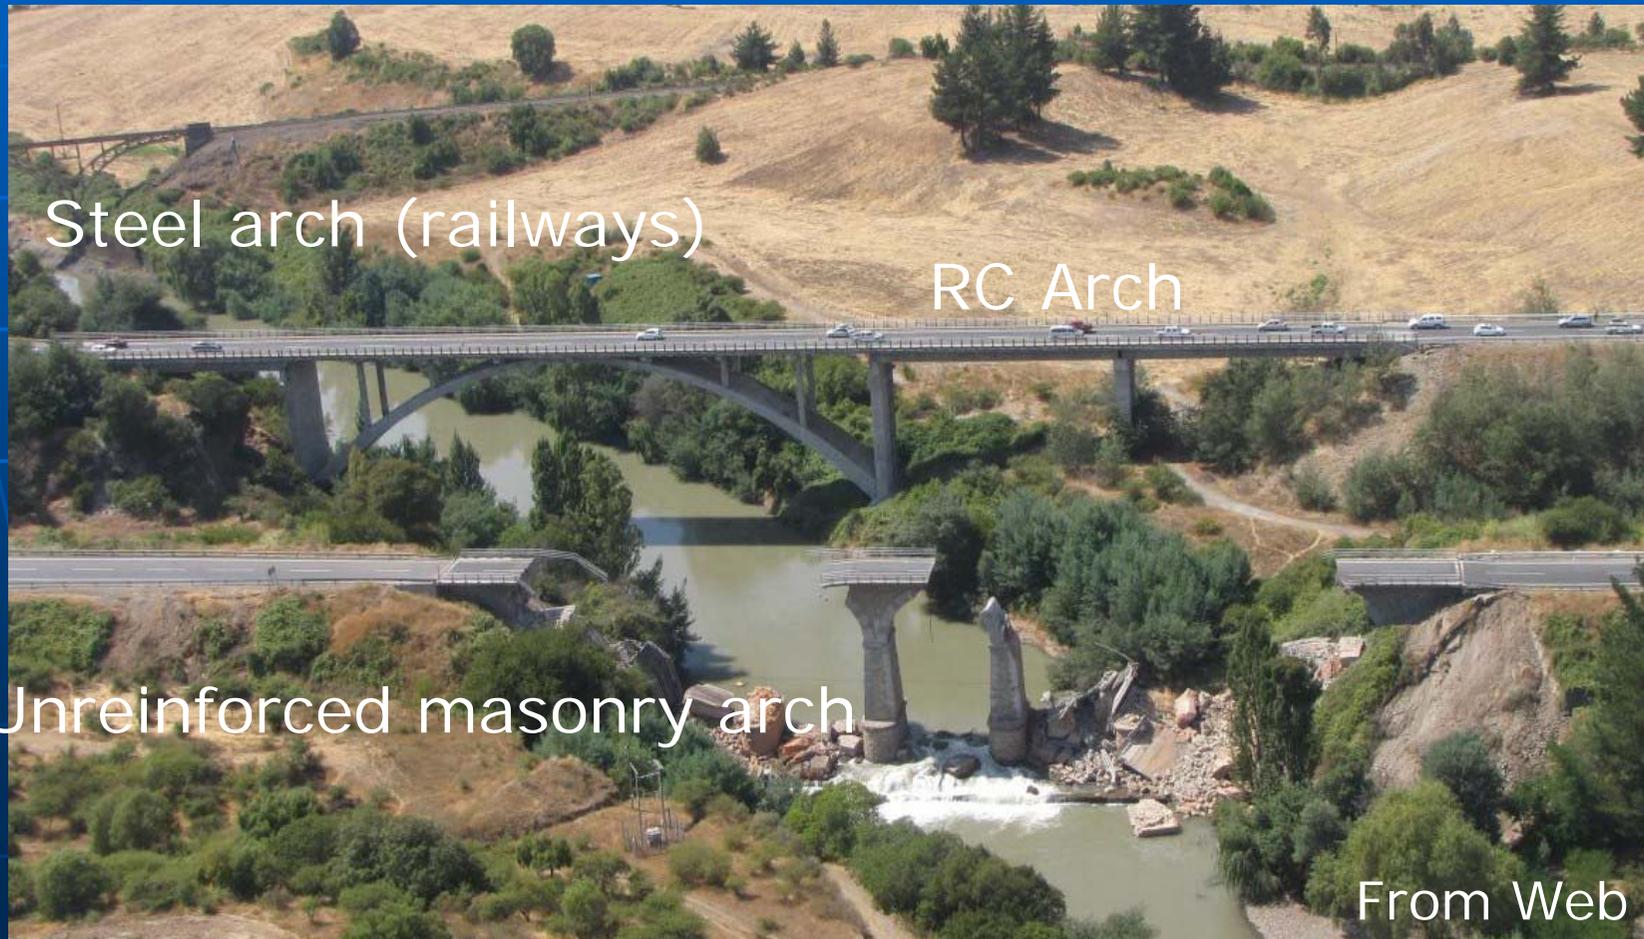
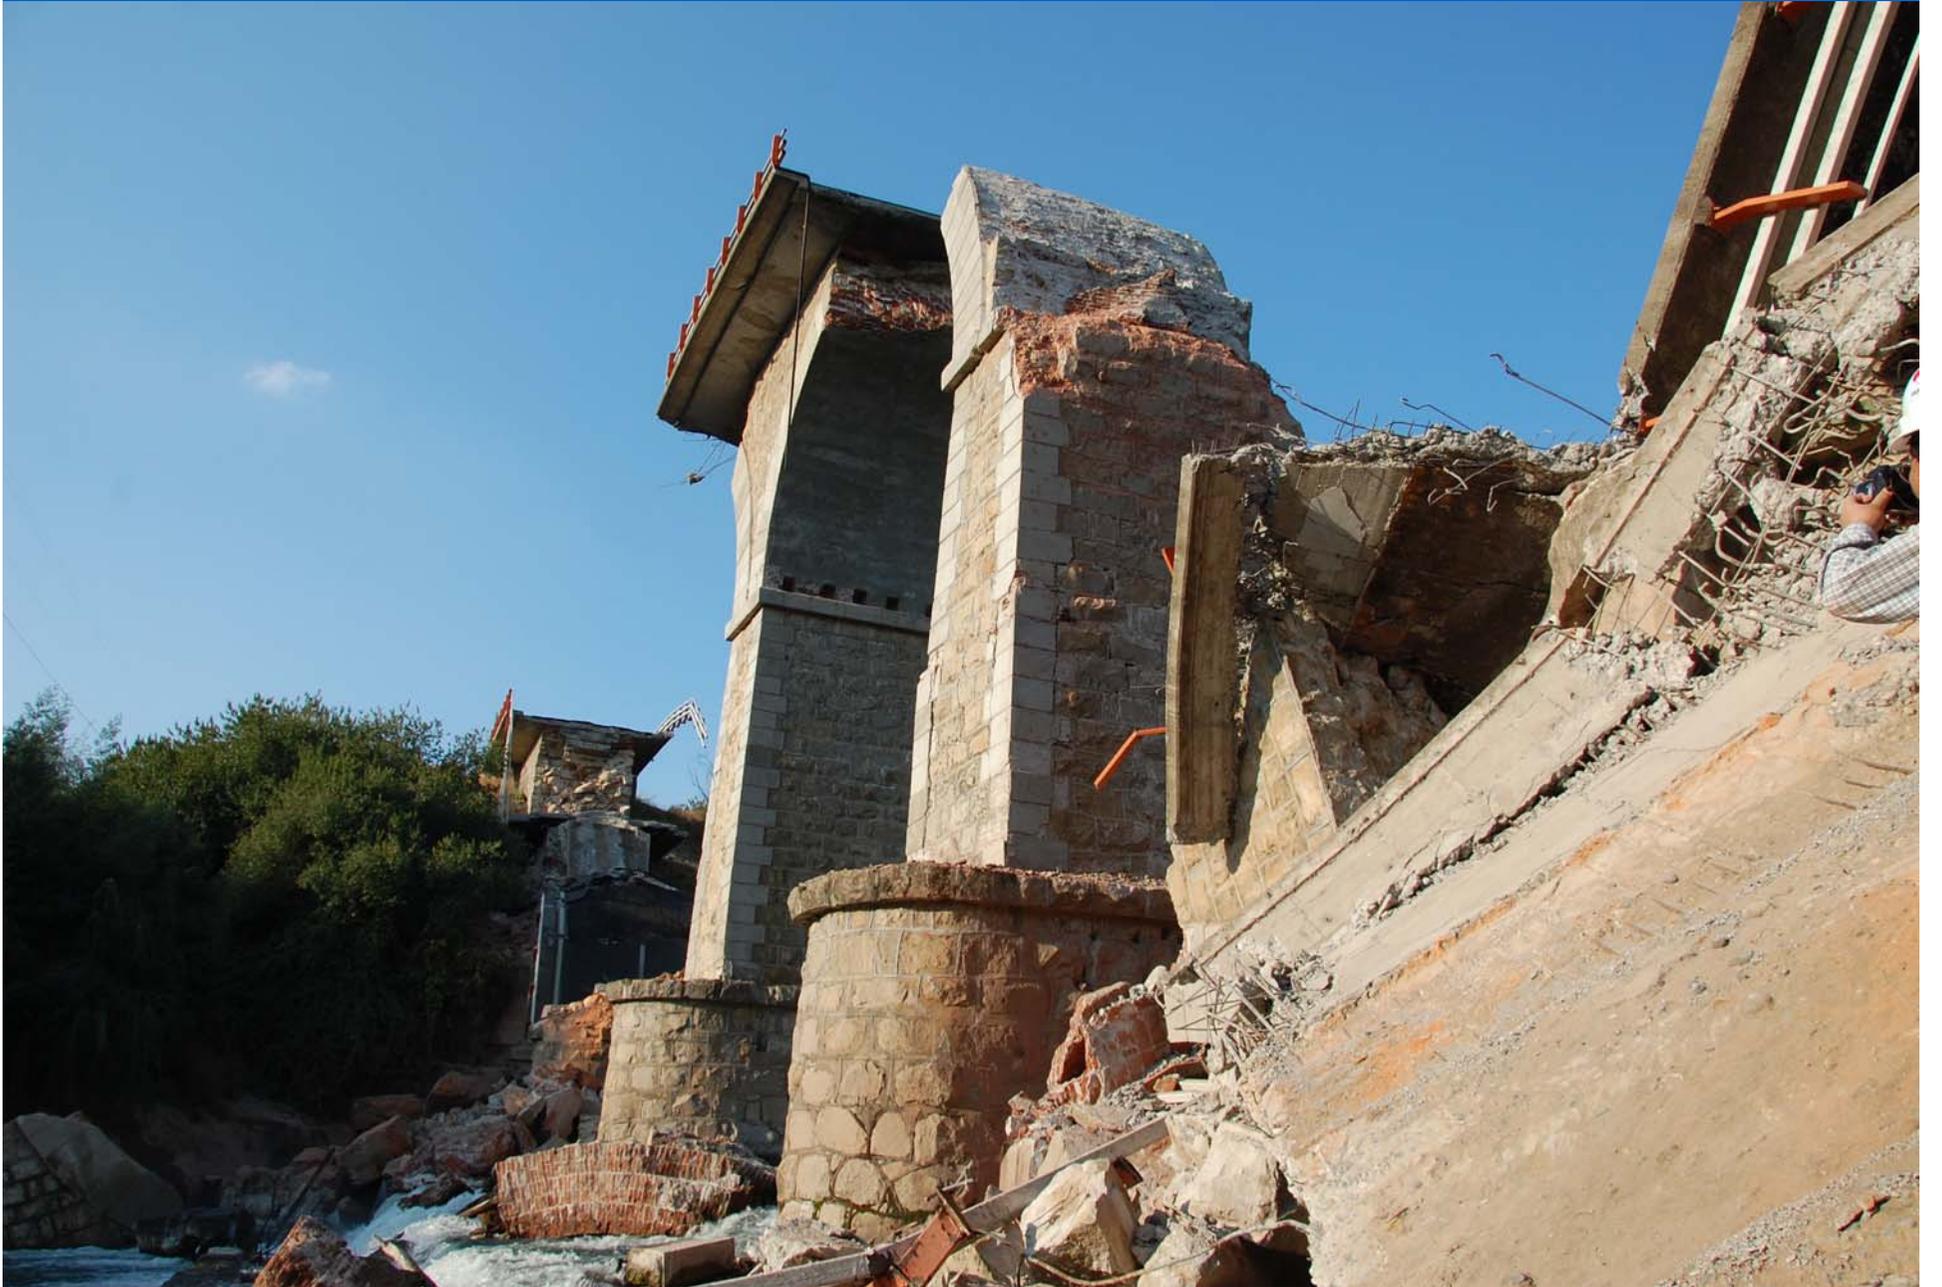
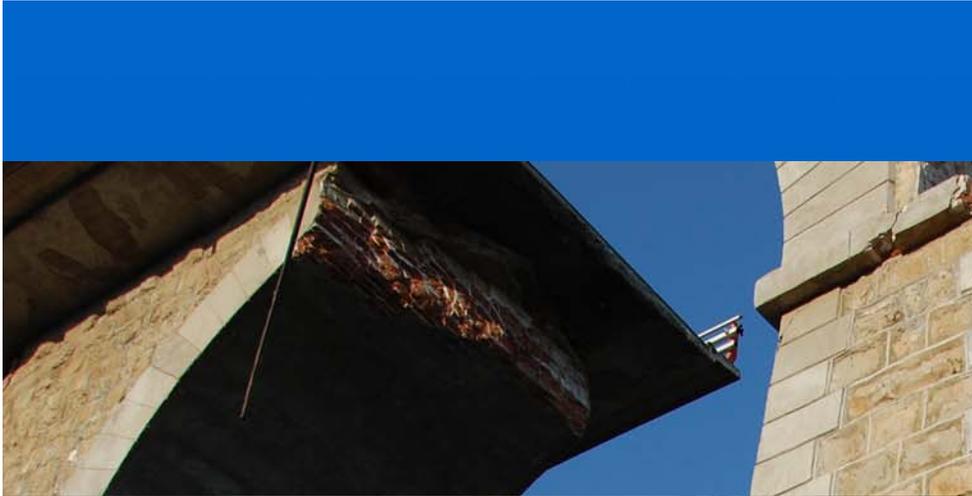
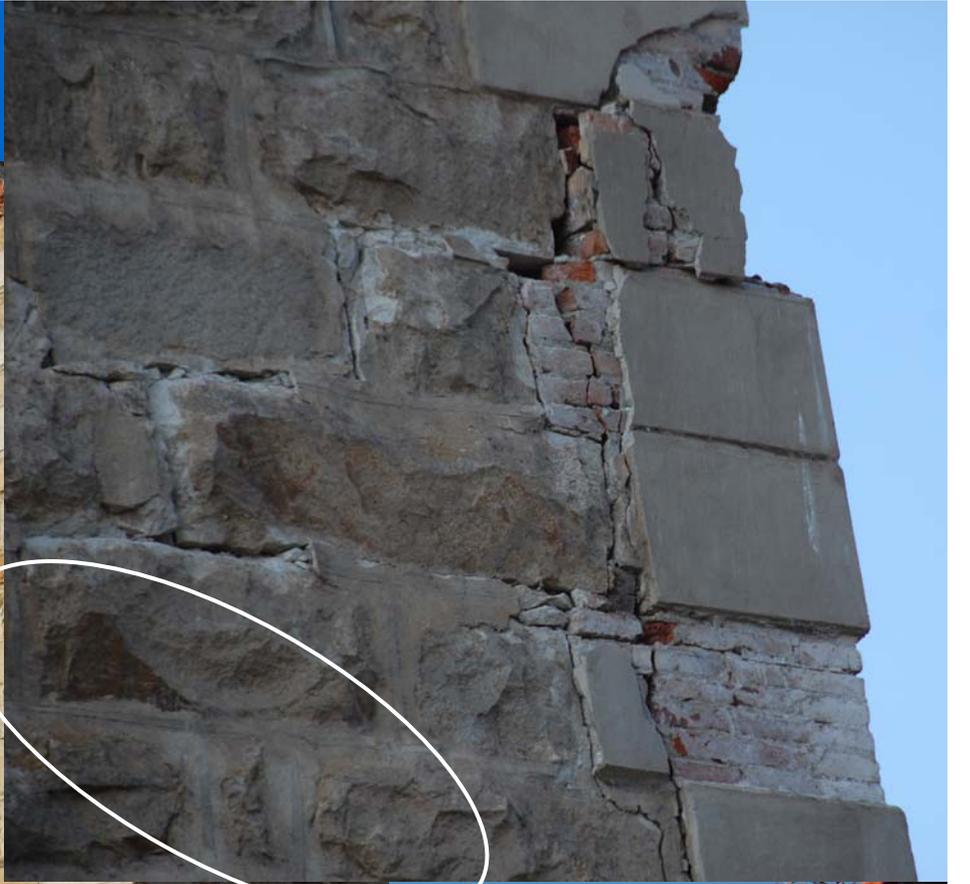
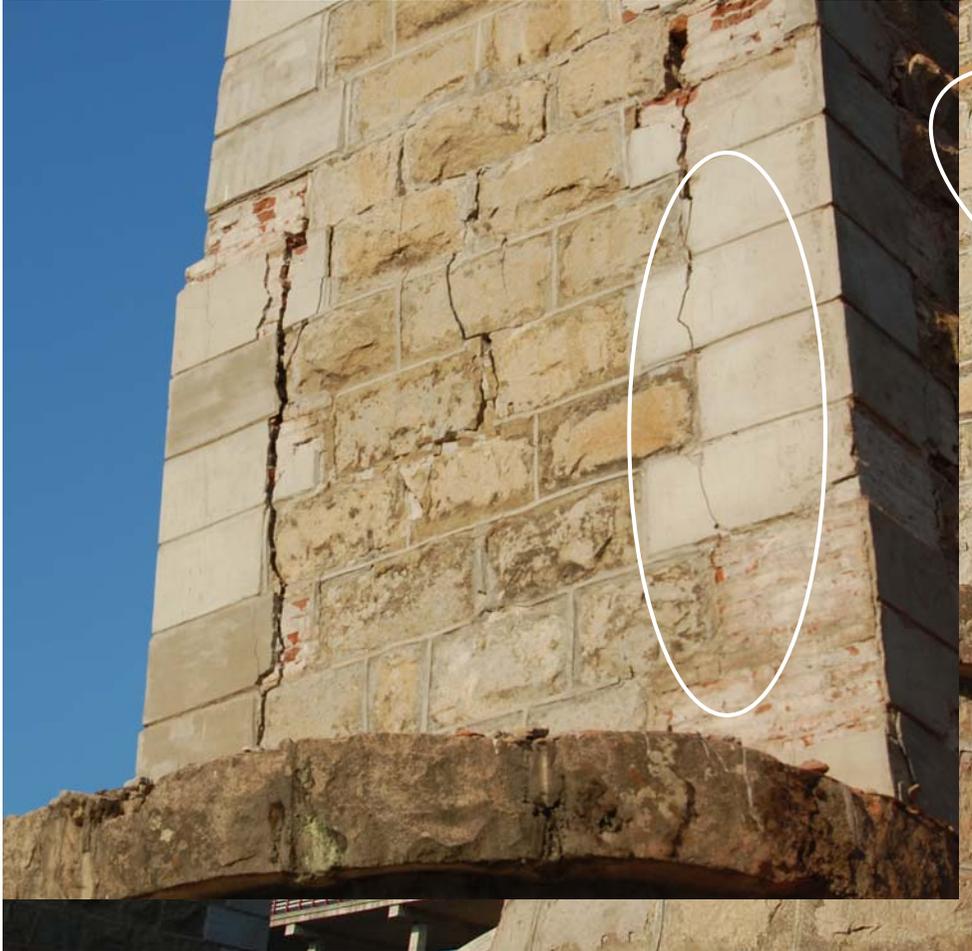
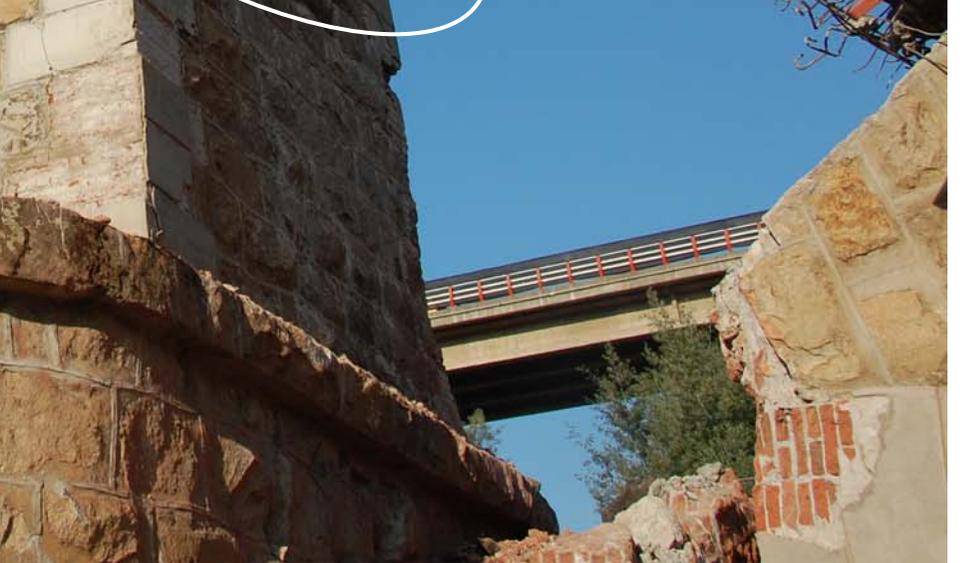
## Rio Claro Bridge

A 140 years old unreinforced masonry bridge built in 1870

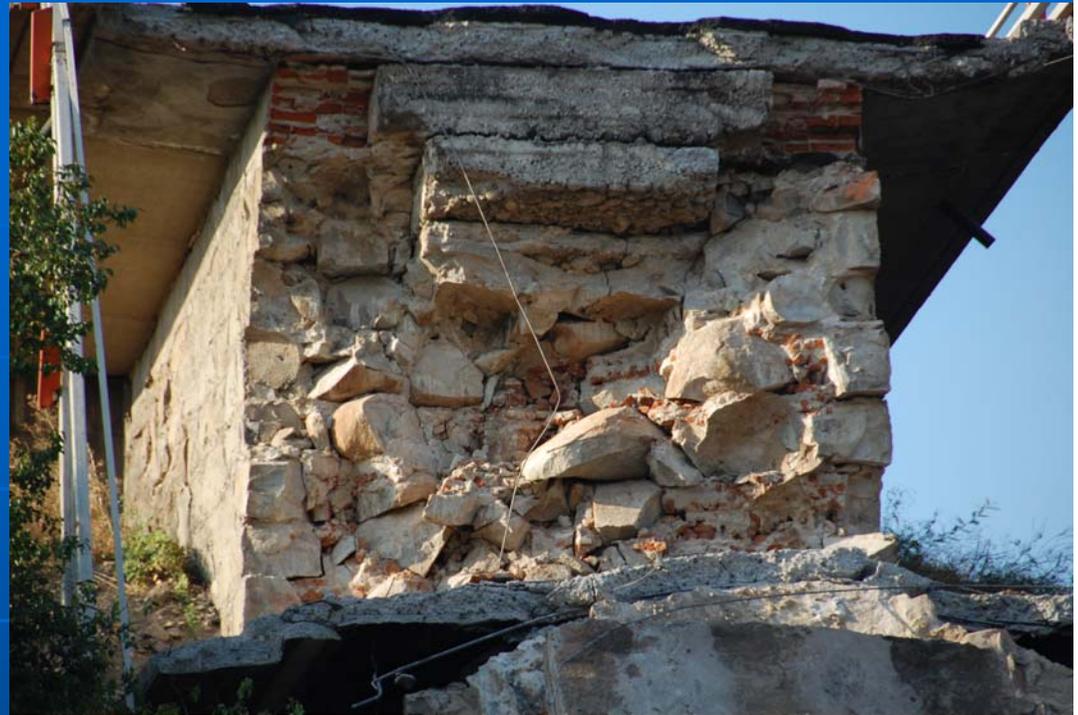
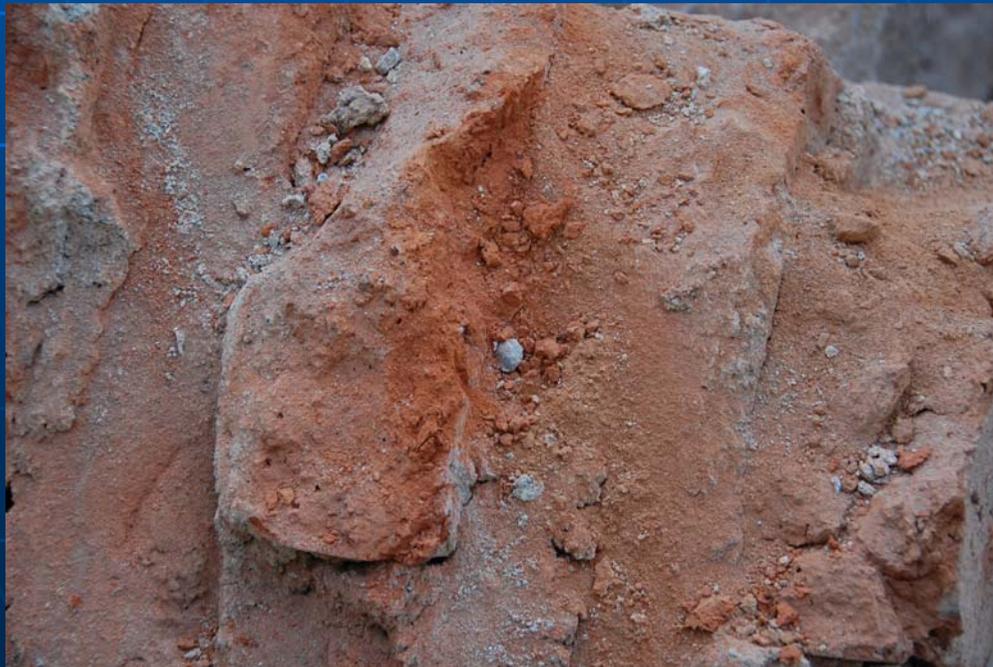
Claro Bridge  
survived heavy  
duty for long time

Brittle masonry  
easy to remove  
clay soil

- Arch crown was only 3m thick
- It must be very tough to survive heavy traffic

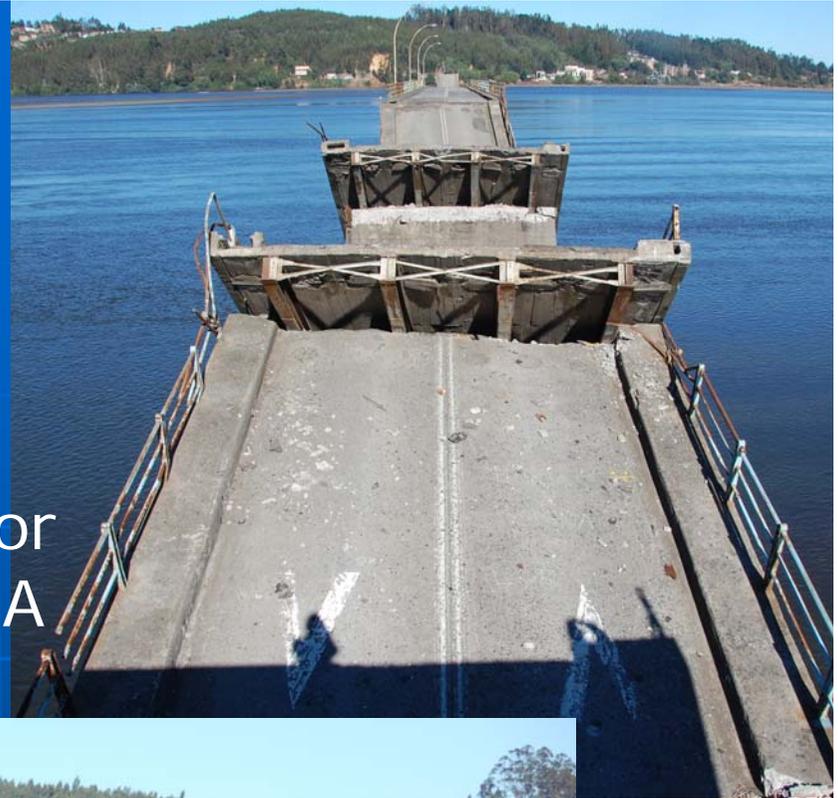
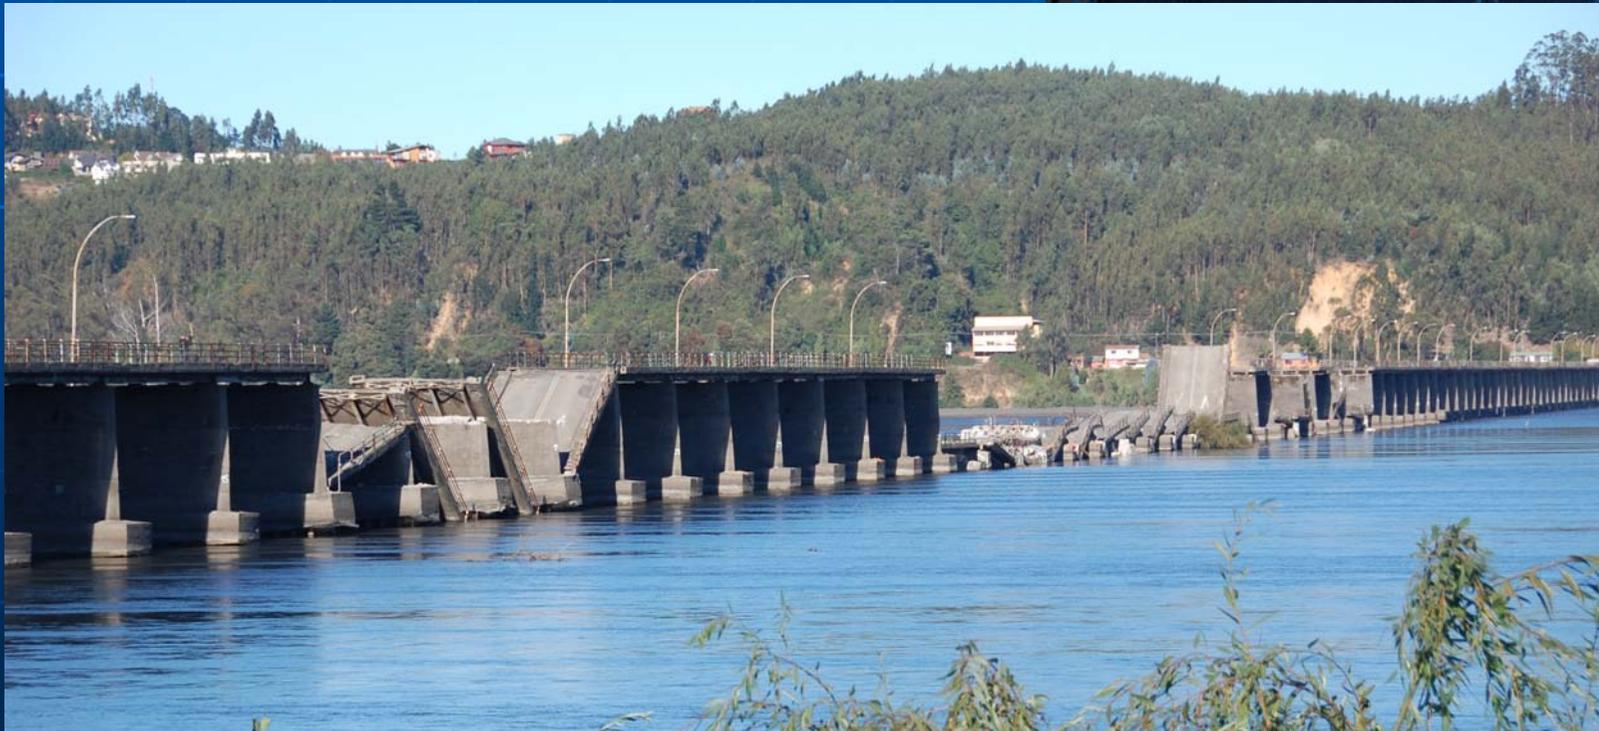
## Bio Bio Bridge

- Built in 1930s
- Recognized to be insufficient for traffic since 1990s based on JICA evaluation

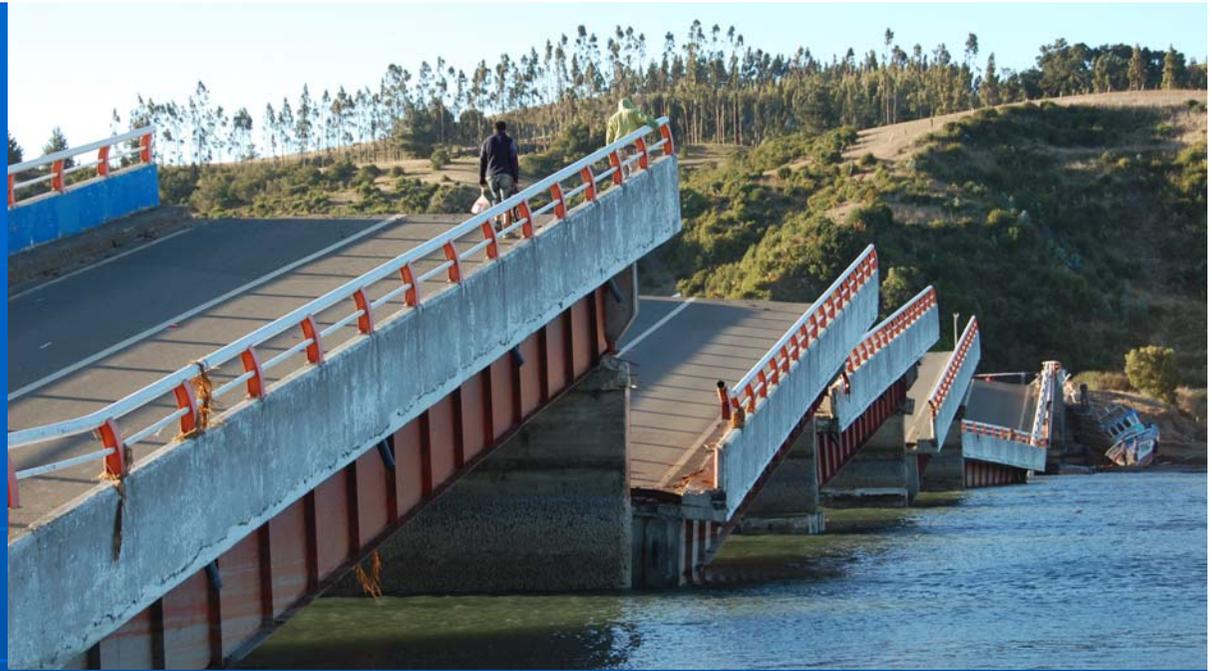
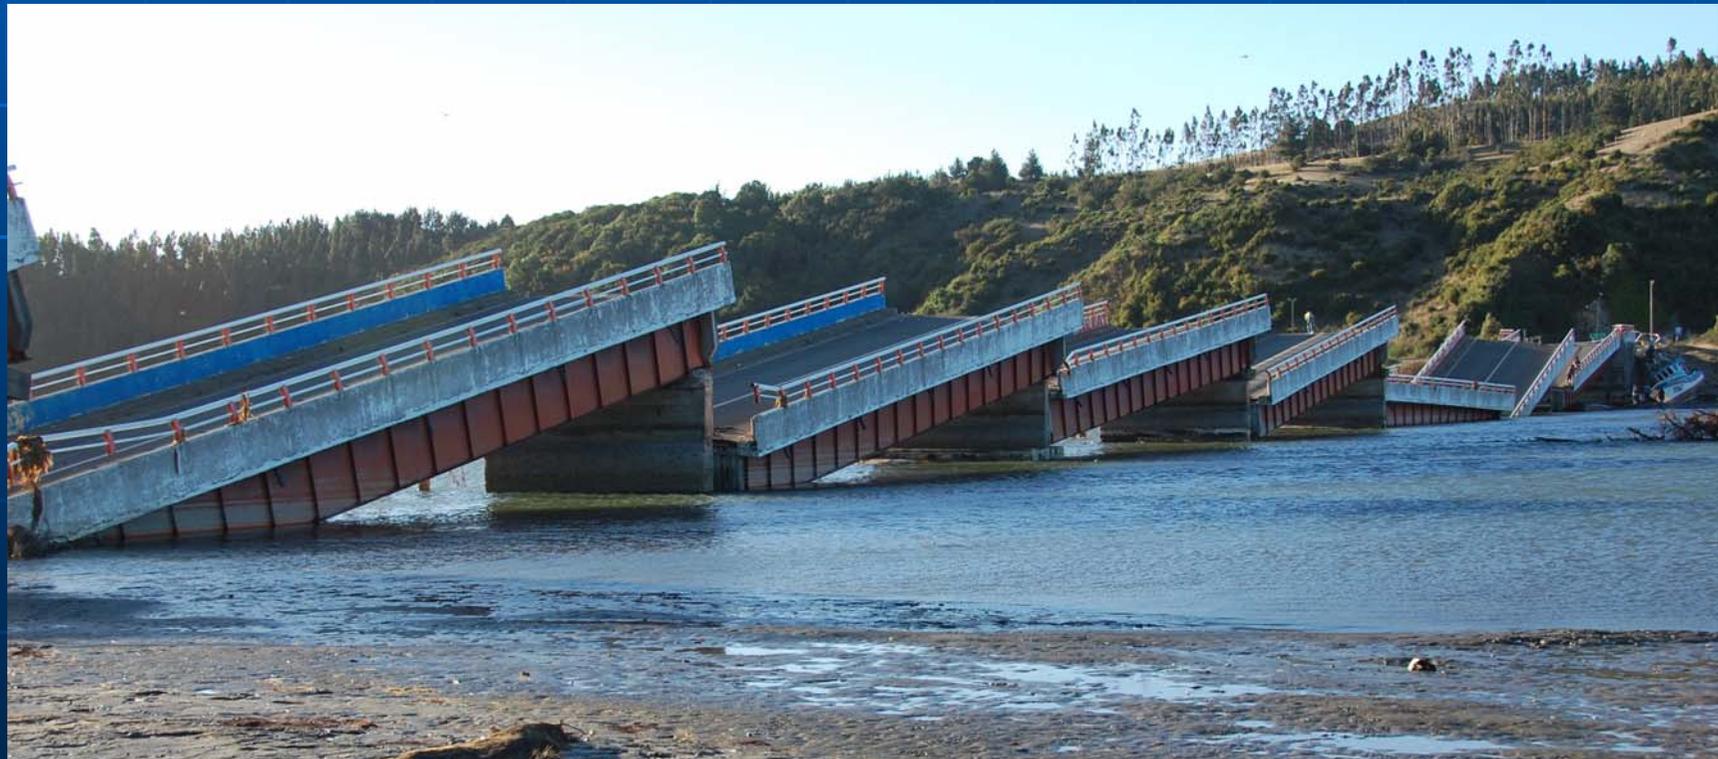
# Tubul Bridge Arauco

Insufficient  
performance  
of foundations

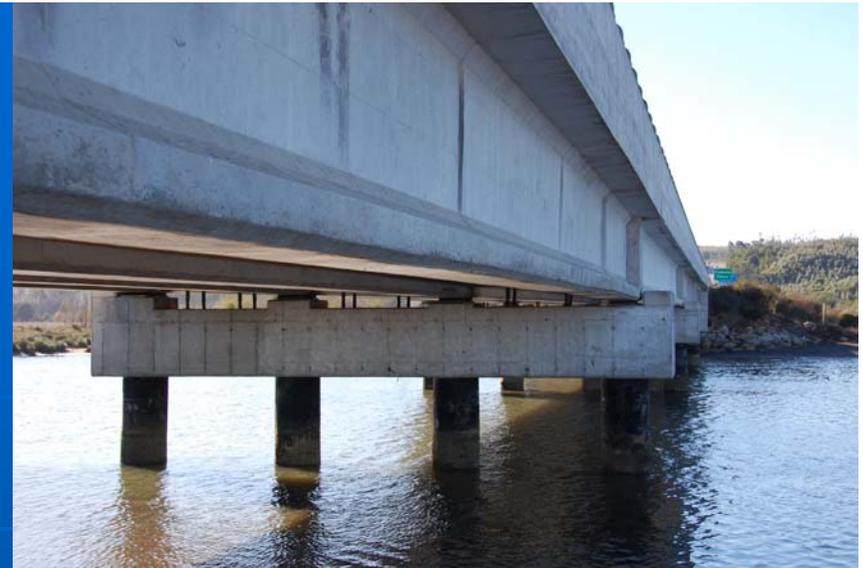
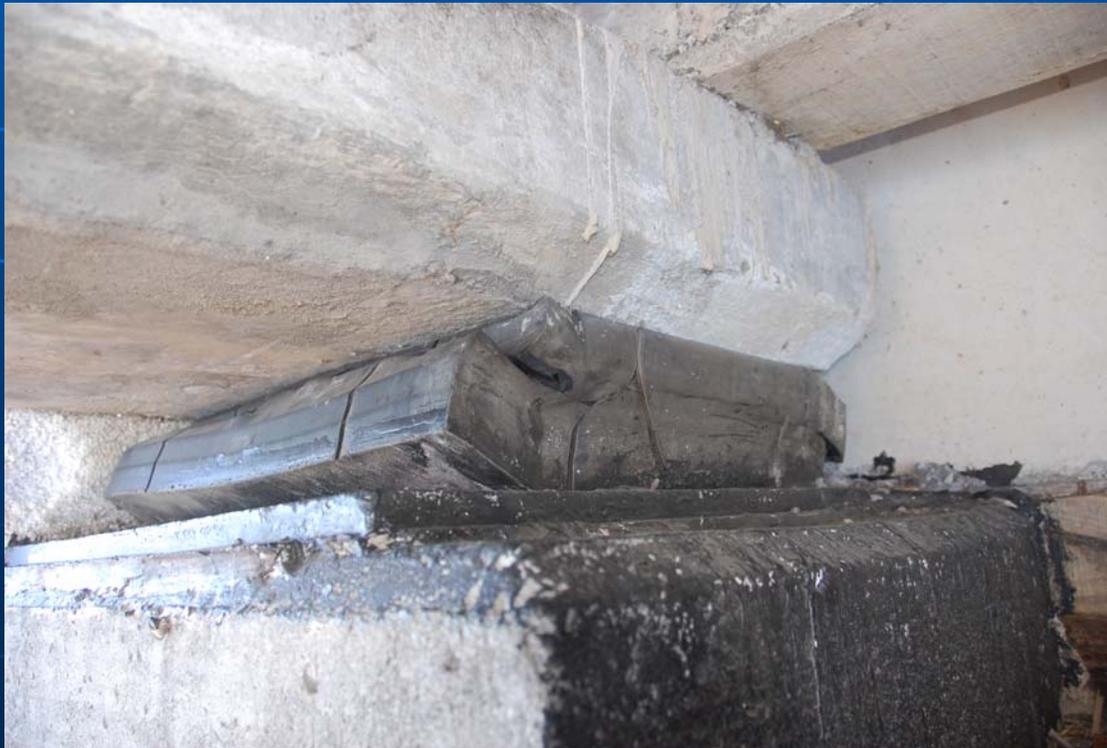
Las Ballenas Bridge

# Rupture of Elastomeric Bearing

A 15 cm tall  
60cm by 60cm  
elastomeric  
bearing ruptures  
due to shear at  
shear strain of  
about 70%

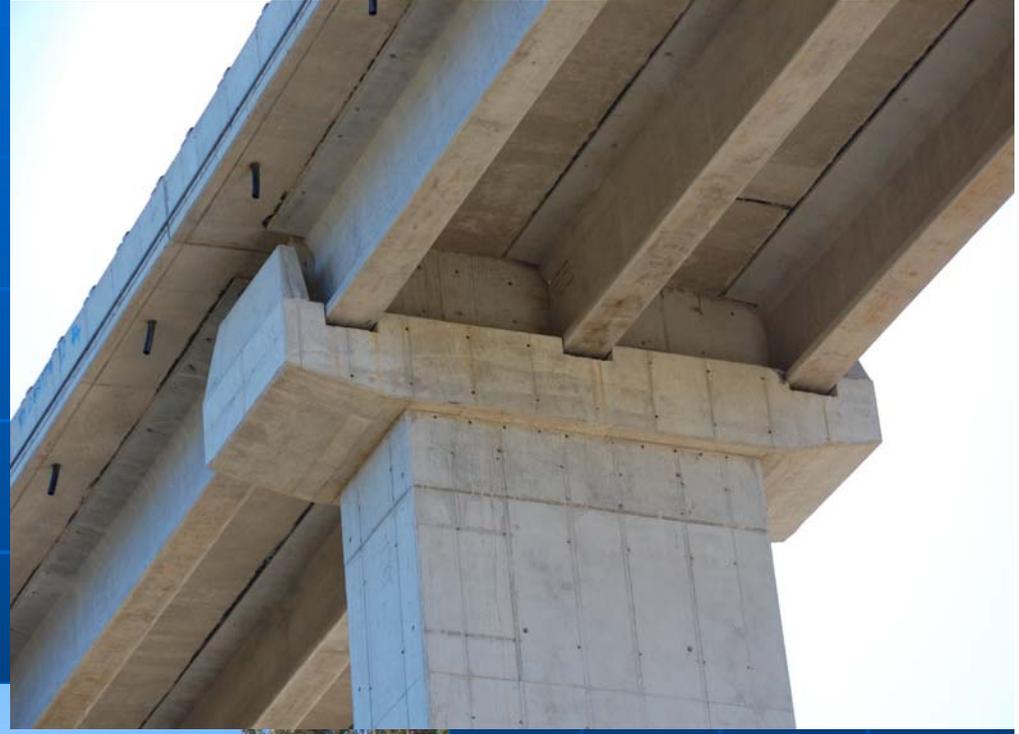
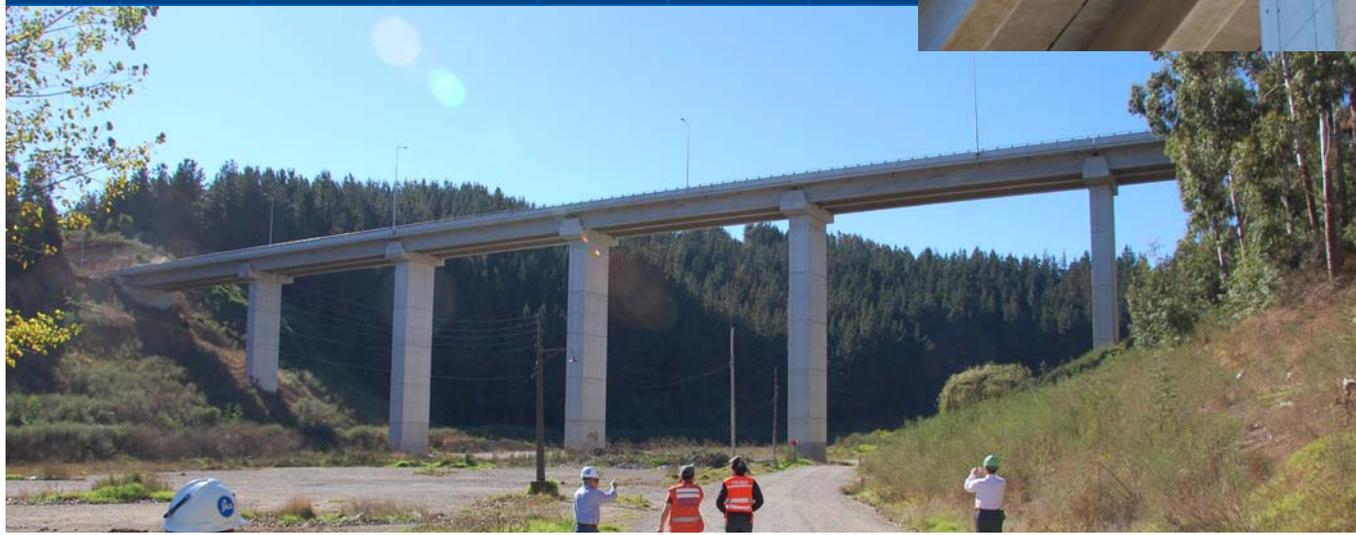
A new bridge constructed based on the existing Chile design survived with only very minor damage

- Side stoppers
- Diaphragms
